ITEM: Hammond Drive Property Assessment Update

# Hammond Drive Assessment Update

September 20, 2016

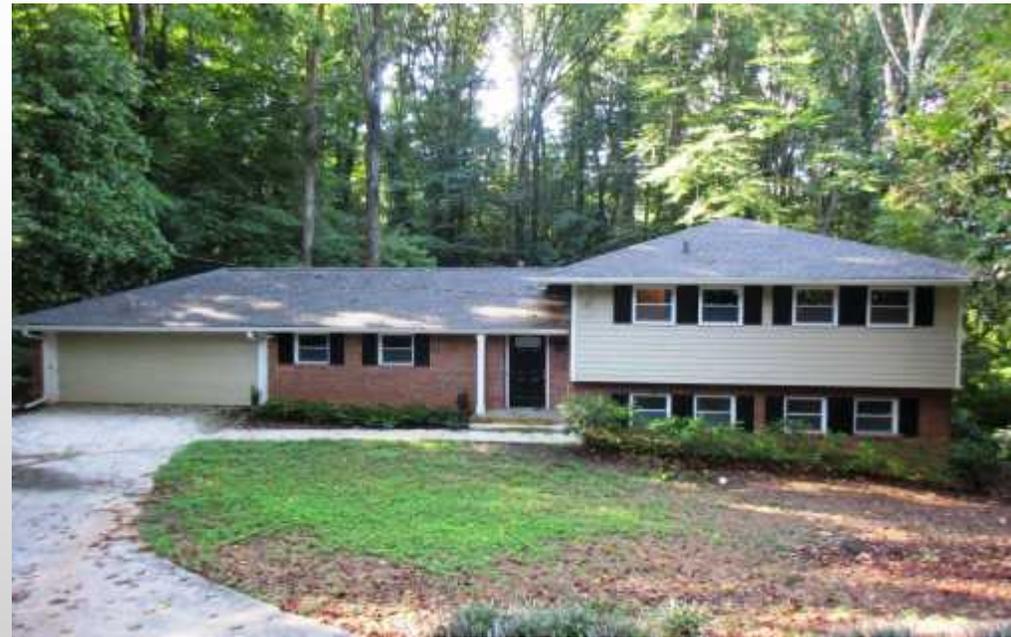
## 521 Hammond Drive

- House was renovated and is in generally Good condition. Was built in 1958 and has potential to have Lead Based Paint and Asbestos within the house.
- Estimated repairs (\$10,500)
  - Lot draining, moisture in basement (\$5,000+)
  - Driveway Surface broken in many places(\$2,500)
  - Plumbing
    - Hot Water Heater over 10 years old (\$1,500)
    - No Expansion Tank(\$350)
  - Electrical
    - Numerous receptacle issues (\$750)
  - Cleaning of the house (\$400)

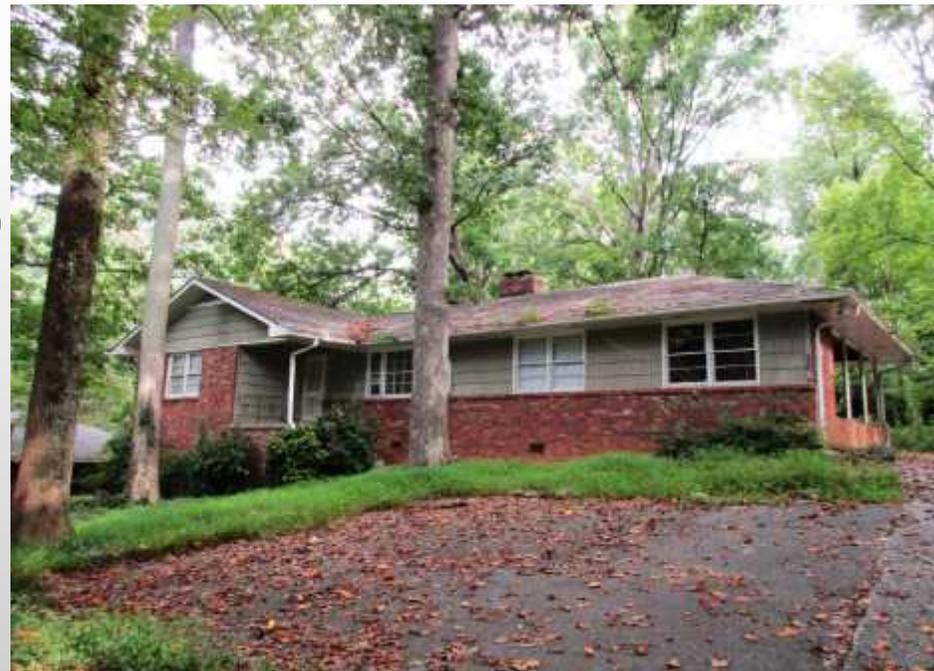
## 550 Hammond Drive

- House was built in 1956 and is in **Poor Condition (many repairs needed)**. Has considerable signs of vermin activity with a severe roach infestation. Pre 1978 home and has potential to have Lead Based Paint and Asbestos within the house.
- Estimated repairs (\$44K+)
  - Roof, soffit and gutters are in poor condition (\$15K)
  - Basement show signs of active moisture penetration (\$5K)
  - Driveway and sidewalk are deteriorated (\$12K)
  - Electrical Panel and outlets need numerous repairs (\$5K)
  - HVAC duct work and T-stat repairs (\$2K)
  - Sub Flooring under Bathrooms water damage (\$4K)

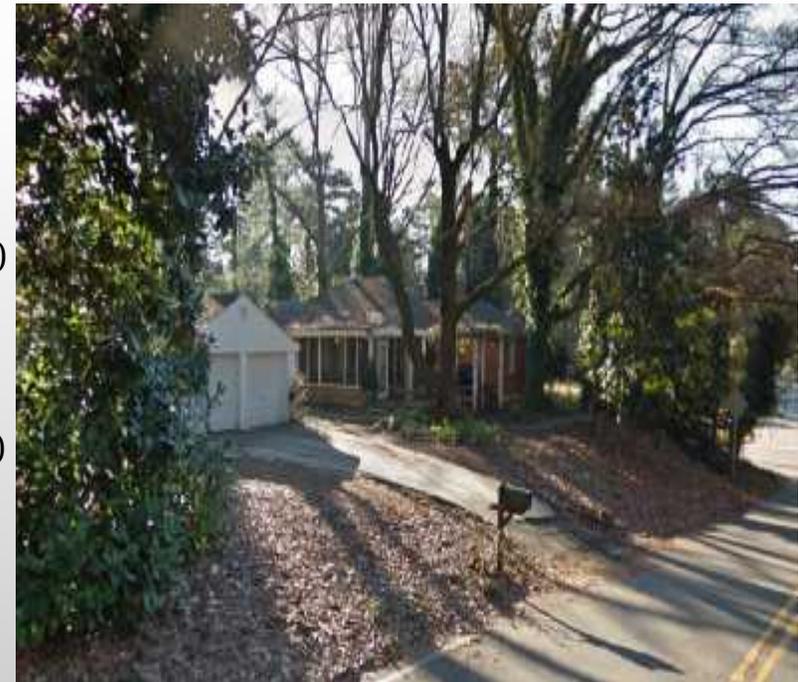
## 418 Hammond Drive

- House was built in 1950 and is in **Poor Condition (many repairs)**. Pre 1978 home and has potential to have Lead Based Paint and Asbestos within the house.
- Estimated repairs (\$50K+)
  - Roof, soffit and gutters are in poor condition (\$20K)
  - Basement show signs of active moisture penetration (\$5K)
  - Foundation has cracks in the walls and block are shifted (\$10-20K)
  - Driveway and sidewalk are deteriorated (\$8K)
  - Electrical Panel and outlets need numerous repairs (\$10K)
  - Kitchen Sub Flooring has sever water damage and wood rot (\$10K)

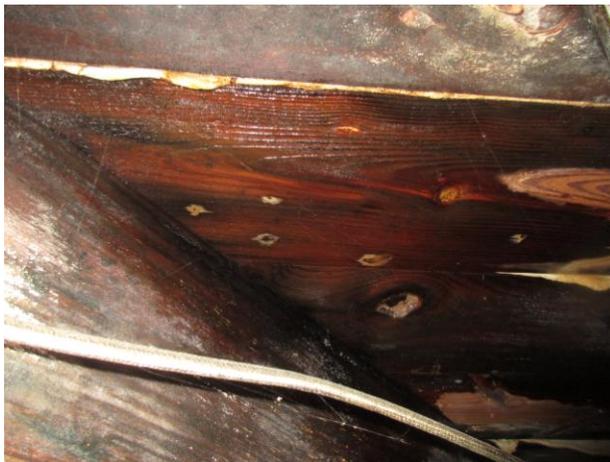
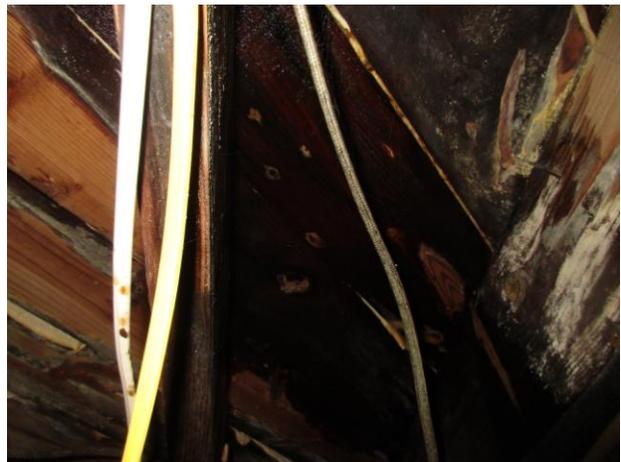
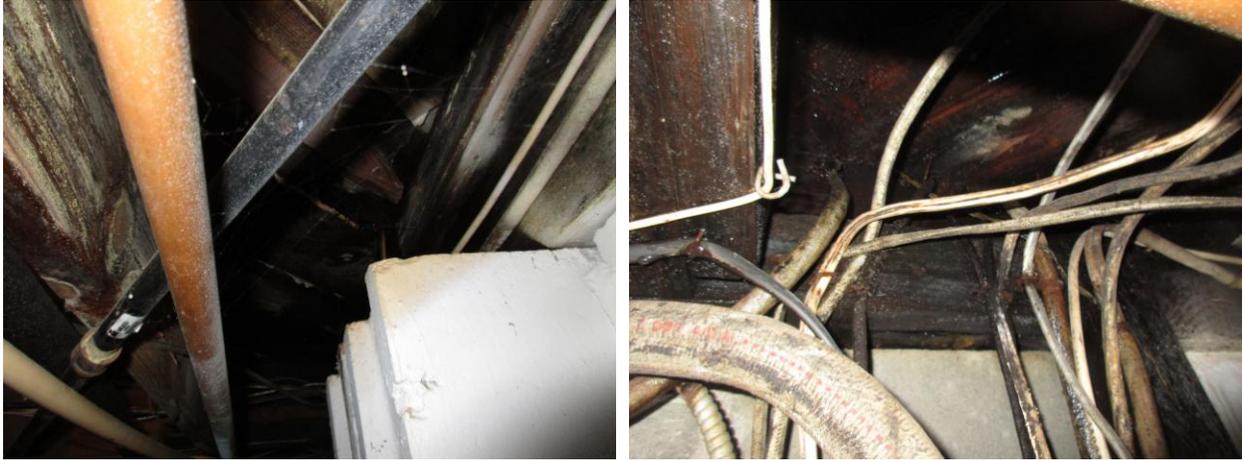
- **Major Concern, Repair:** The floor structure below the kitchen shows evidence of possible rot. Rot weakens the structure and causes building damage. Rot develops where untreated wood is in contact with moisture and/or where wood/soil contact exists. Damaged wood needs to be repaired or replaced and the conditions that have promoted the rot should be corrected. A framing repair company or structural engineer who is expert in wood framing be consulted to further evaluate this condition and the remedies available.

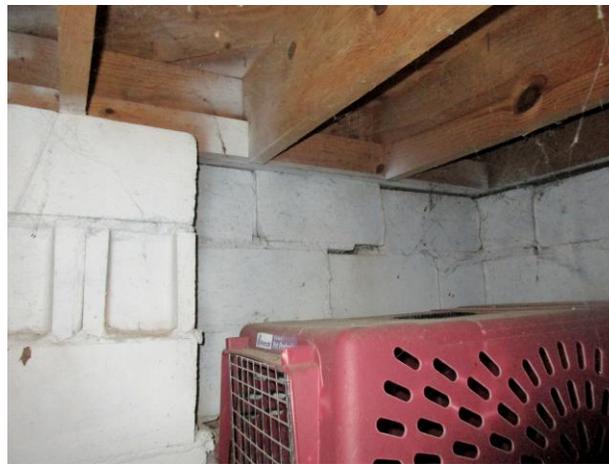
### Foundation

- **Repair:** The cracks observed in the right front corner of the foundation need to be sealed. Cracks of this nature are usually the result of soil pressure. The size, pattern, and location of these cracks does not suggest a serious problem at present. Keep water away from the foundation: review the lot and roof drainage improvements in the Exterior and Roofing sections of this report. If these cracks should worsen, a structural engineer who is familiar with foundation repair or qualified foundation repair contractor needs to be consulted.

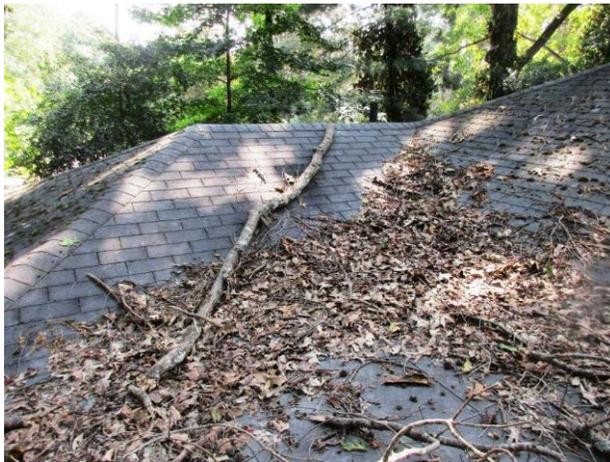
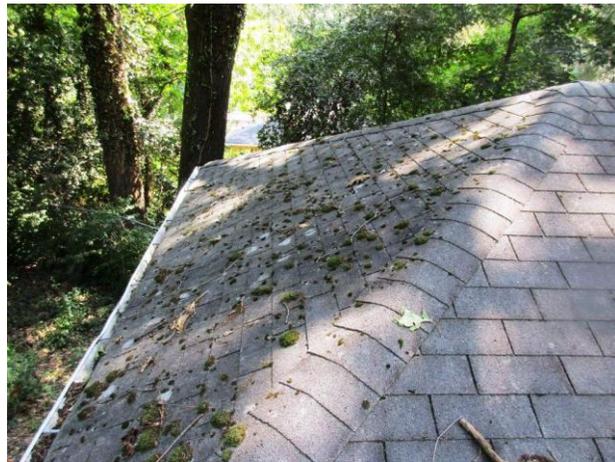
- **Repair:** The roofing is near the end of its life. Minor repairs might be possible to extend the roof life and to defer leaks. Damaged or missing roofing material should be repaired. All roof penetrations need to be examined and sealed as necessary. Expect to replace the roof soon.
- **Repair:** Debris needs to be removed from the roofing to reduce risk of leaks and early roof wear.
- **Monitor:** The roofing is in fair condition. The roofing shows evidence of moss and organic build up in shaded areas. This condition may reduce the life expectancy of the roofing. Trimming or removing trees could improve this condition.

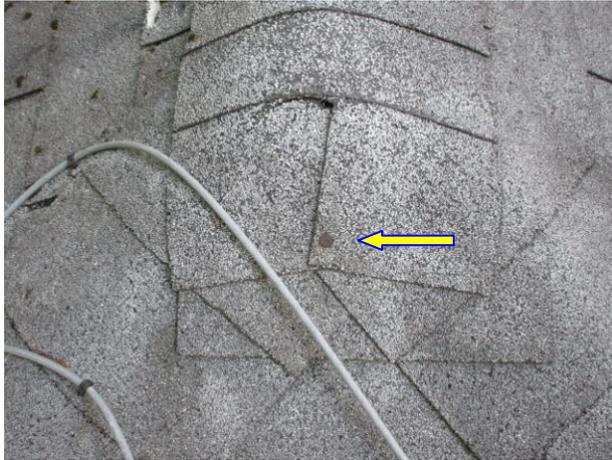
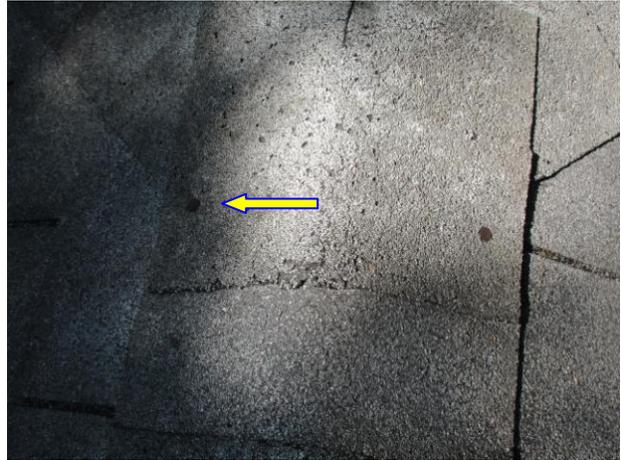
- **Repair:** Nail heads are exposed at the ridge and hip caps. They need to be sealed to reduce risk of leaks. A qualified roofing contractor needs to be consulted to further evaluate this condition and make the necessary repairs.

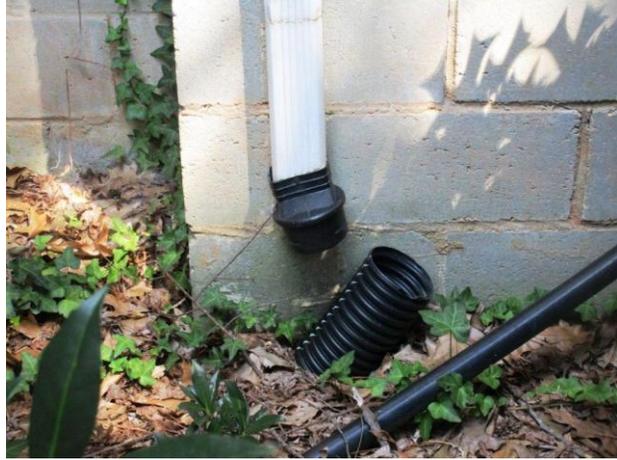
- **Repair:** The disconnected downspout at the right rear area of the home needs to re-secured.
- **Repair:** The downspout(s) should discharge water at least five (5) feet from the house. Storm water should be encouraged to flow away from the building at the point of discharge. The front downspout needs to be re-connected to the auxiliary line.

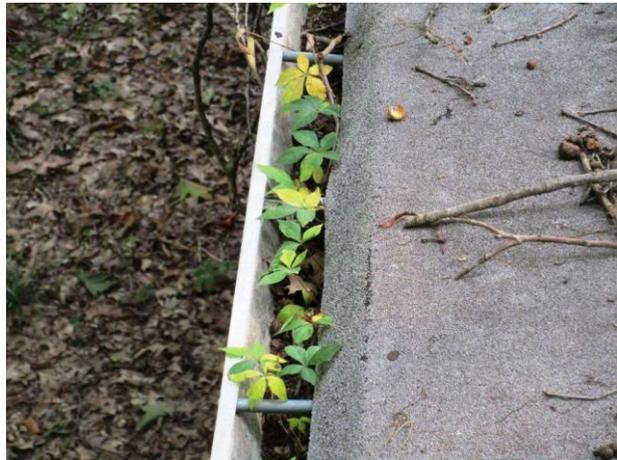
- **Repair:** The gutters require cleaning to avoid spilling roof runoff around the home – a potential source of water entry or water damage.

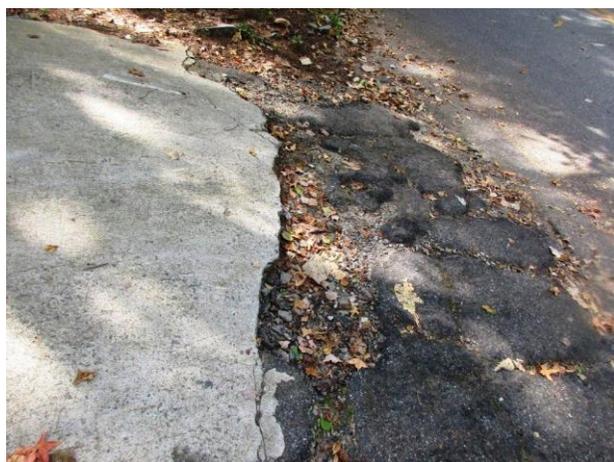
- **Major Concern:** The driveway surface is in a deteriorated condition. Resurfacing is necessary to correct this condition. A qualified concrete contractor needs to be consulted to further evaluate this condition and make the necessary repairs.

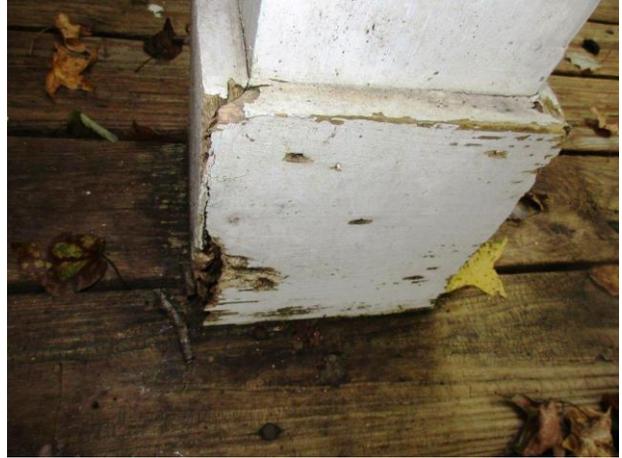
### Pergola

- **Repair:** The pergola trim shows evidence of substantial rot. All moisture damaged wood needs to be replaced so as to prevent more serious damage in the future. A qualified contractor needs to be consulted to further evaluate this condition and make the necessary repairs.

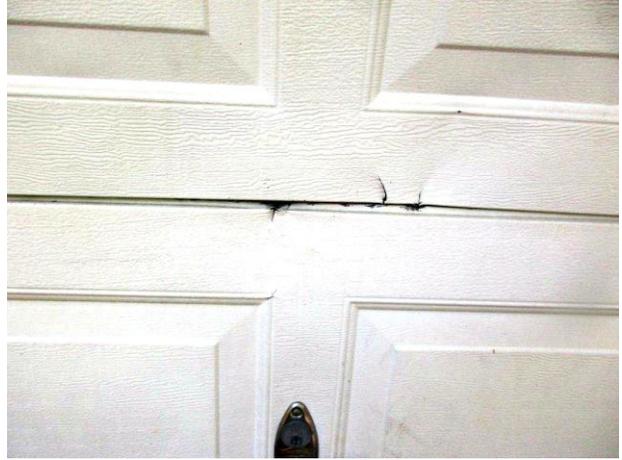
- **Repair, Safety Issue:** The left and right overhead garage doors are damaged and need repair. A qualified garage door technician needs to be consulted to further evaluate this condition and make the necessary repairs. **Note:** The detached garage was inaccessible at the time of the inspection.

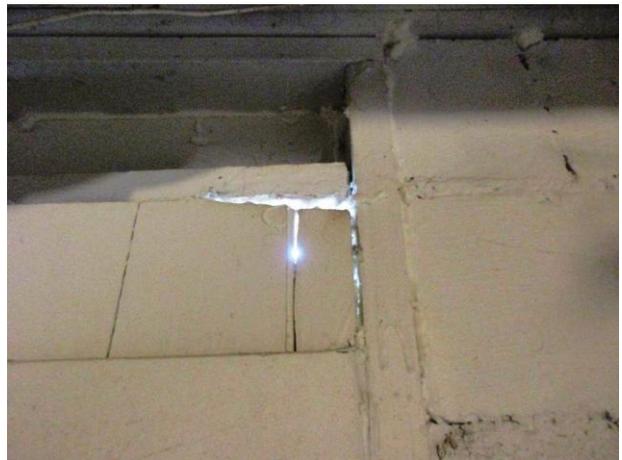
- **Repair:** It is recommended that the basement door be replaced with a proper exterior door and that all gaps to the exterior be completely sealed. A qualified contractor needs to be consulted to further evaluate this condition and make the necessary repairs.

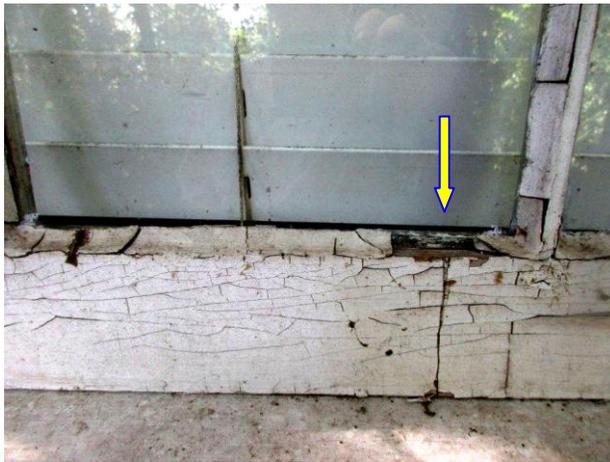
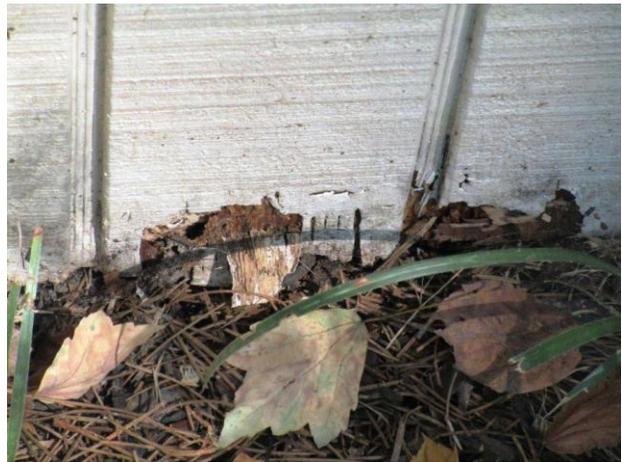
- **Repair:** The exterior of the home needs to be painted to preserve the building materials.
- **Repair:** Wood/soil contact at the base of the garage siding needs to be eliminated. Rotted or damaged siding that is uncovered needs to be repaired. These areas are at risk of additional hidden damage.

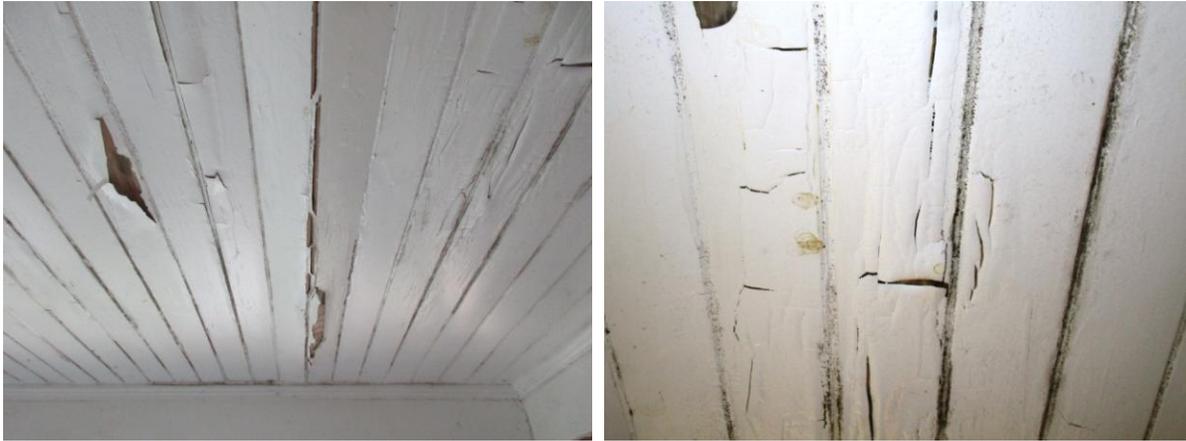
- **Repair:** Damage to the interior finish was observed in the patio ceiling. Active water leaking is suspected. A qualified contractor needs to be consulted to further evaluate this condition and make the necessary repairs.

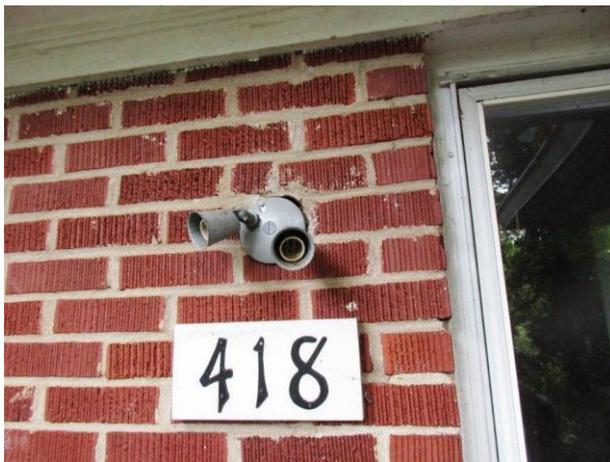
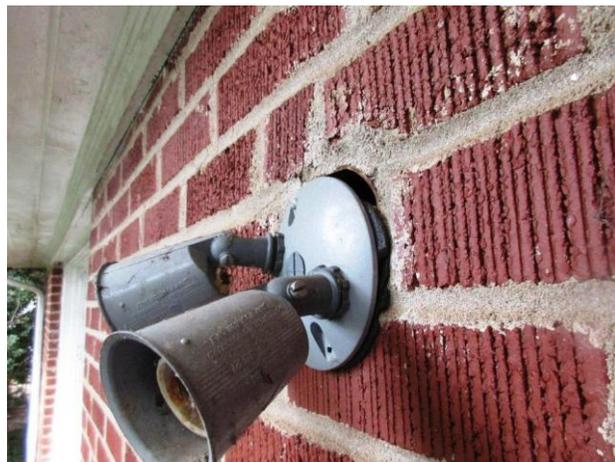
- **Repair:** The light fixtures in the left front bedroom and the right front bedroom need to be replaced.
- **Repair:** The front porch light fixture is loose and needs to be repaired or replaced.

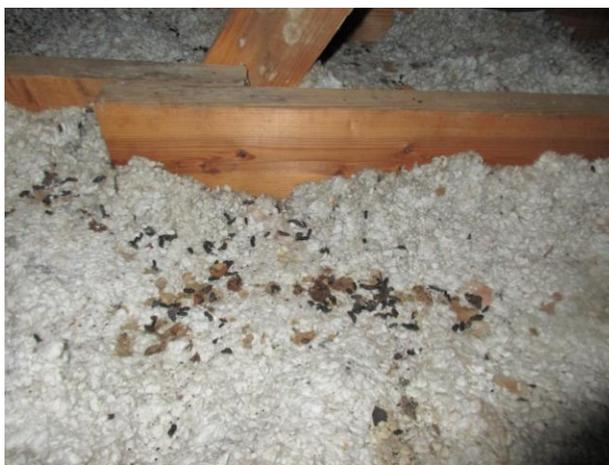
- **Repair:** There is evidence of previous vermin activity in the attic. A pest control specialist needs to be consulted in this regard.

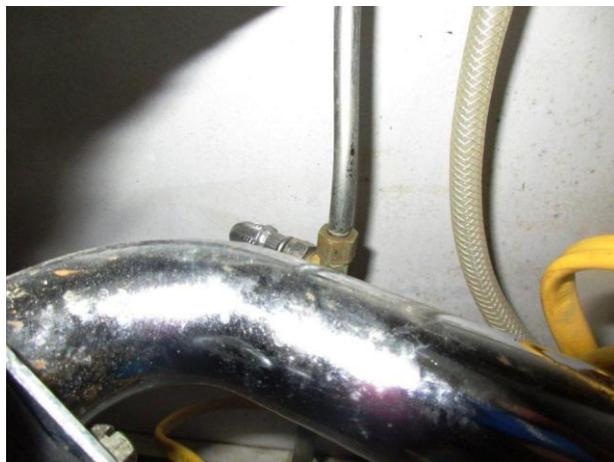
- **Repair:** A shut off valve is needed for the dishwasher water supply line. A qualified plumber needs to be consulted to further evaluate this condition and make the needed repairs.
- **Repair:** The incoming water supply line is leaking and needs repair. A qualified plumber needs to be consulted to further evaluate this condition and make the needed repairs.

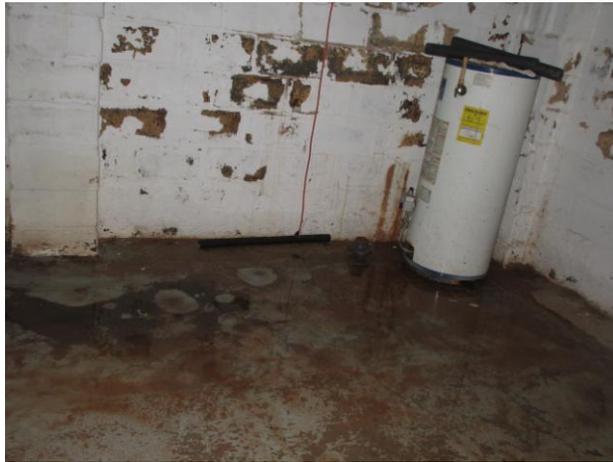
- **Major Concern, Repair:** The supply piping is leaking is leaking below the refrigerator. This has resulted in significant standing water in the basement and subfloor below the kitchen. A qualified contractor needs to be consulted to further evaluate this condition and make the necessary repairs.

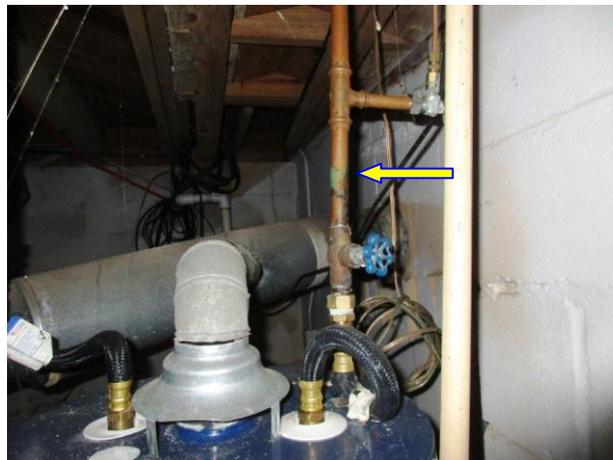
- **Repair:** The discharge piping serving the Temperature and Pressure Relief (TPR) Valve for the water heater is not properly plumbed. A qualified plumber needs to be consulted to further evaluate this condition and make the necessary repairs.
- **Repair, Safety Issue:** The water heater is missing the secondary expansion valve or tank. This has been a requirement since 1998. A qualified plumber needs to be consulted to further evaluate this condition and make the necessary repairs. Additional information about secondary expansion tanks can be found at: <http://www.watts.com/pages/learnAbout/thermalExpansion.asp?catId=64>

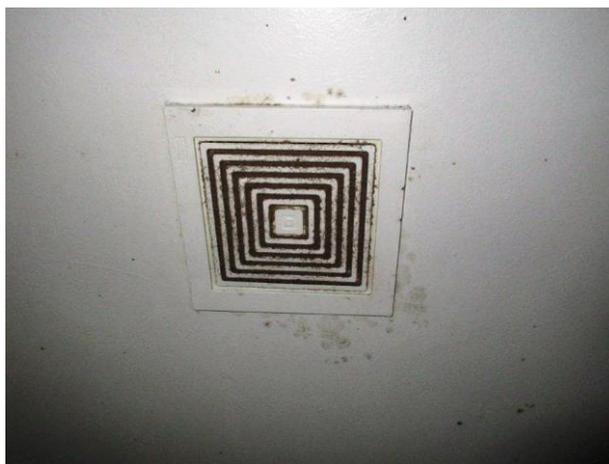
- **Repair:** The hallway bathroom fan was inoperative at the time of the inspection. A qualified contractor needs to be consulted to further evaluate this condition and make the necessary repairs.

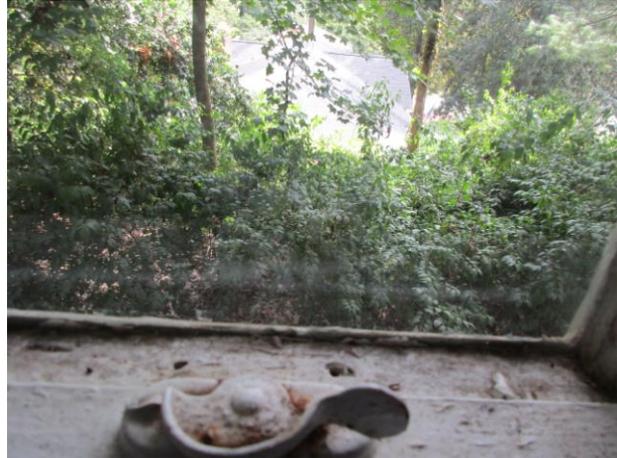
- **Repair:** One of the right rear bedroom windows is cracked and needs to be replaced. A qualified contractor needs to be consulted to further evaluate this condition and make the necessary repairs.
- **Repair:** The window lock keeper for the hall bathroom is missing and needs to be replaced. A qualified contractor needs to be consulted to further evaluate this condition and make the necessary repairs.

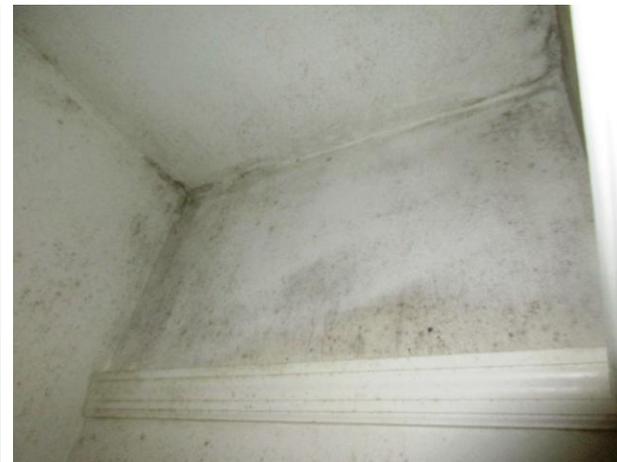
- **Repair:** Signs of mildew were observed in the hall bathroom and bathroom closet. Cleaning with a mildewcide is needed.

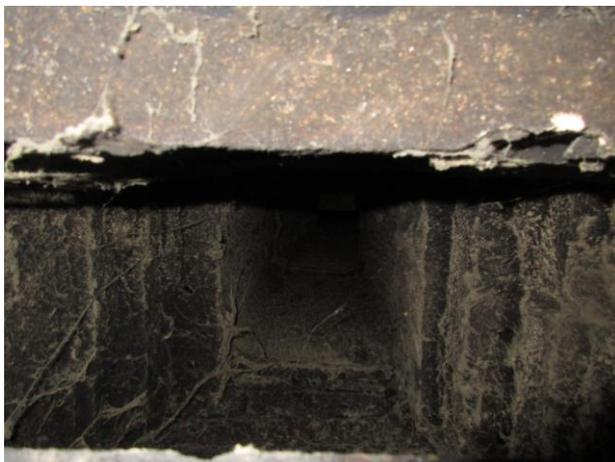
- **Repair:** The fireplace chimney needs to be cleaned and inspected prior to operation. A qualified chimney sweep contractor needs to be consulted to further evaluate this condition and make the necessary repairs.
- **Repair:** The fireplace damper is missing and needs to be replaced. A qualified contractor needs to be consulted to further evaluate this condition and make the necessary repairs.
- **Repair, Safety Issue:** The floor of the fireplace firebox needs to be repaired for improved safety. A qualified contractor needs to be consulted to further evaluate this condition and make the necessary repairs.

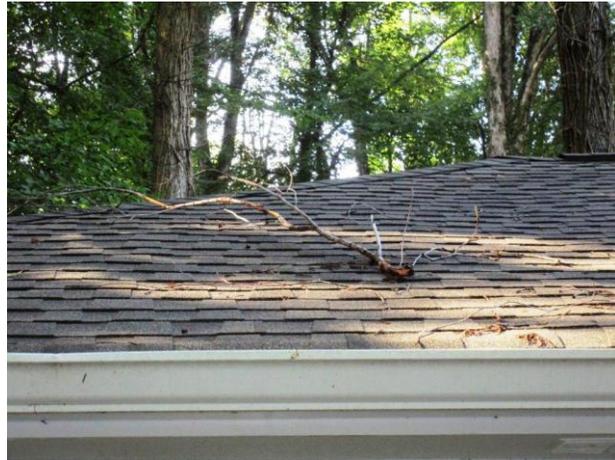
- **Repair:** Debris needs to be removed from the roofing to reduce risk of leaks and early roof wear.

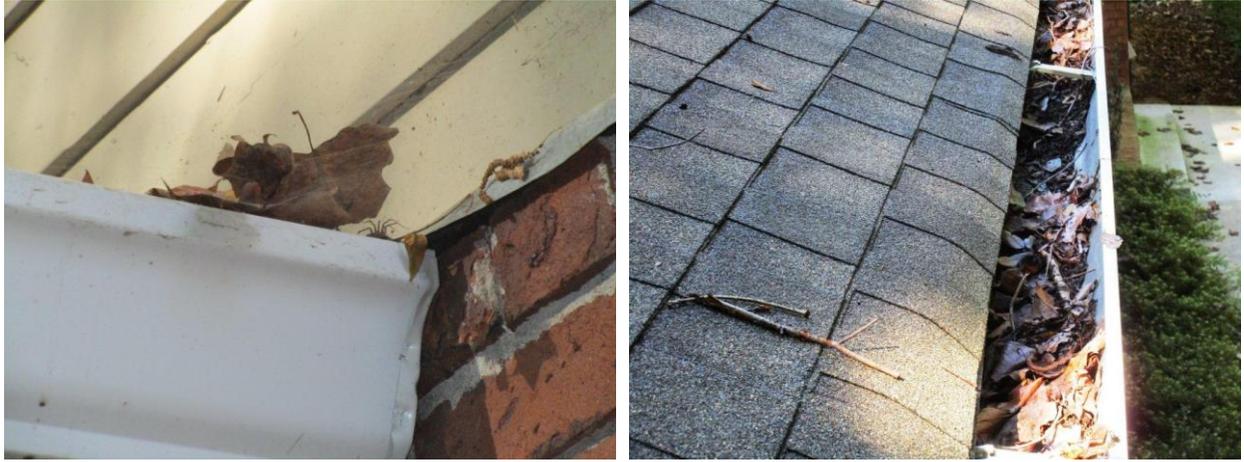
- **Repair:** The gutters require cleaning to avoid spilling roof runoff around the building – a potential source of water entry or water damage.

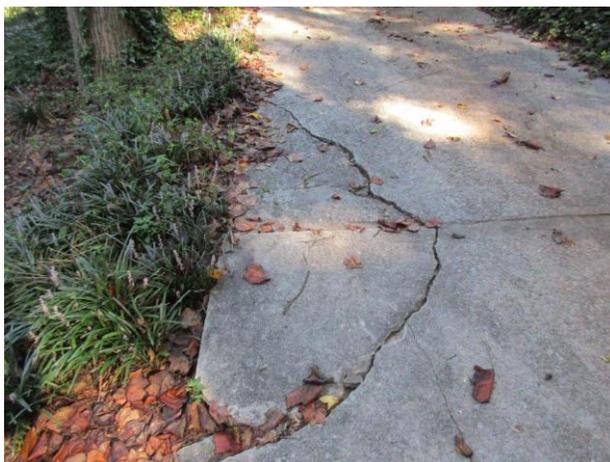
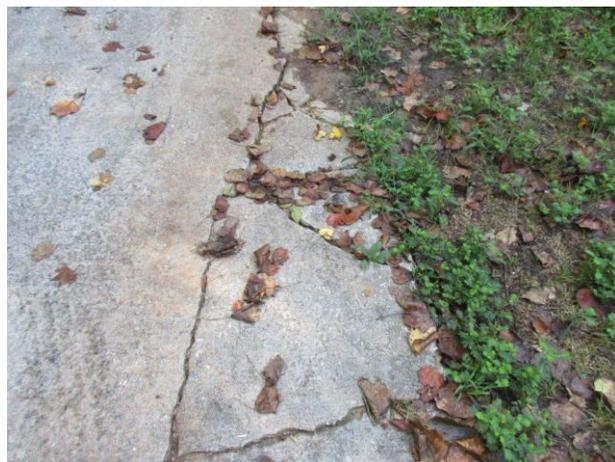
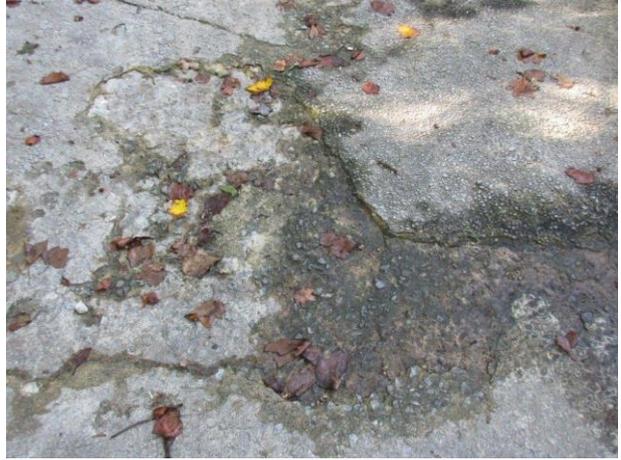
- **Major Concern, Repair:** The driveway surface is in a deteriorated condition. Resurfacing is necessary to correct this condition. A qualified concrete contractor needs to be consulted to further evaluate this condition and make the necessary repairs. (Trip hazards).

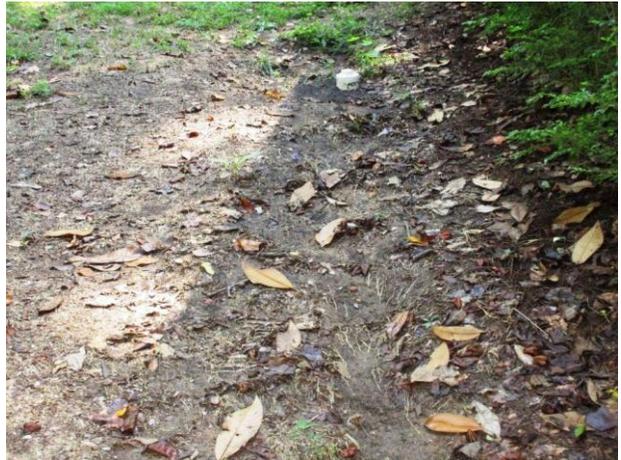
- **Repair:** The grading of the soil at the front and right side of the home needs to be altered for improved erosion control. A qualified landscaping contractor needs to be consulted to further evaluate this condition and make the necessary repairs.

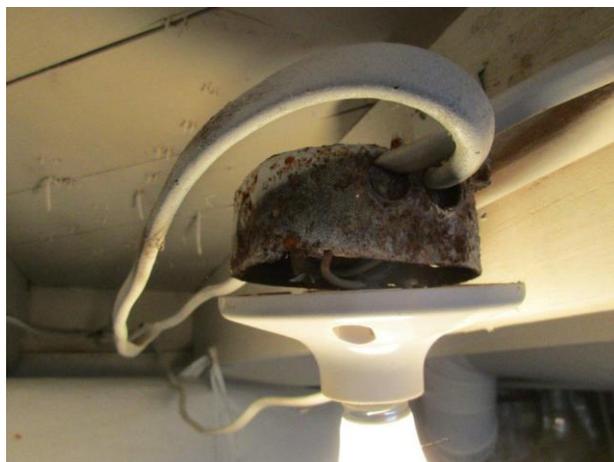
- **Repair:** The loose light fixture in the basement needs to be repaired or replaced.
- **Repair:** The patio door light and the front flood lights were inoperative. If the bulbs are not blown, the circuits need to be repaired.

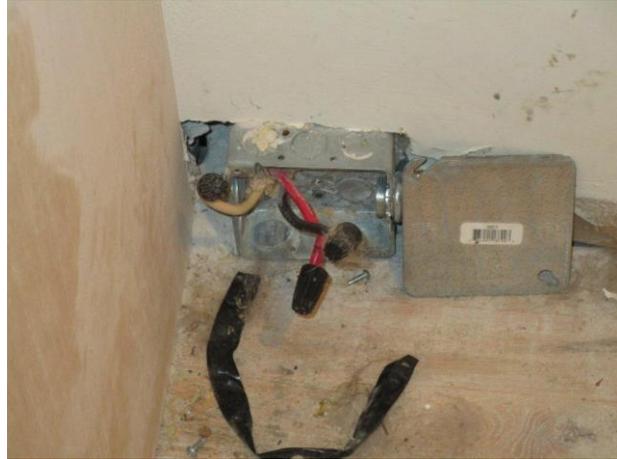
- **Repair:** The upper level bathroom outlet, the front master bedroom outlet, and the right front master bedroom outlet tested with open ground. Ungrounded 3-prong outlets need to be repaired. In some cases a ground wire may be present in the electrical box and simply needs to be connected. If no ground is present “repair” can be as simple as filling the ground slot with epoxy. Better, since having a ground increases safety, a grounded circuit could be strung to this outlet, or a separate ground wire could be connected. Some electrical codes allow the installation of a ground fault circuit interrupter (GFCI) type outlet where grounding is not provided. In this case the GFCI may work but can’t be tested by normal means.
- **Repair:** A receptacle for the electric range needs to be installed.

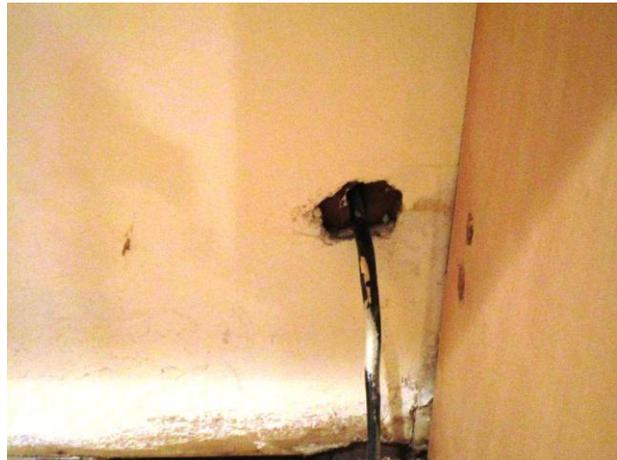
- **Repair, Safety Issue:** A junction box needs to be installed and covered for the dishwasher electrical supply.

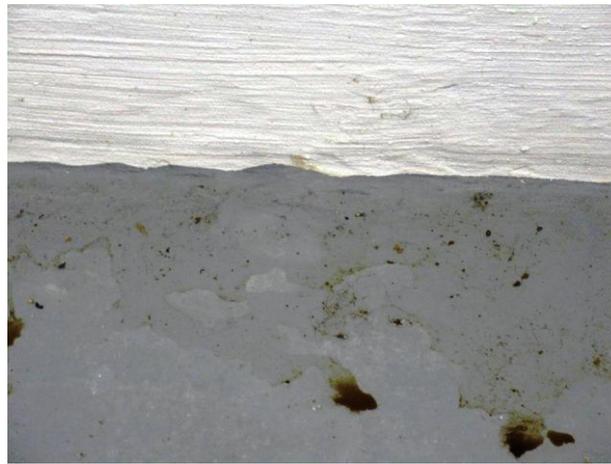
- Major Concern, Repair:** The front basement shows evidence of active moisture penetration. *It should be understood that it is impossible to predict the severity or frequency of moisture penetration on a one time visit to a home.* Virtually all basements exhibit signs of moisture penetration and virtually all basements will indeed leak at some point in time. The vast majority of basement leakage problems are the result of insufficient control of storm water at the surface. The ground around the house should be sloped to encourage water to flow away from the foundations. Gutters and downspouts should act to collect roof water and drain the water at least five (5) feet from the foundation, or into a functional storm sewer. Downspouts that are clogged or broken below grade level, or that discharge too close to the foundation, are the most common source of basement leakage. Please refer to the Roofing and Exterior sections of the report for more information. In the event that basement leakage problems are experienced, lot and roof drainage improvements should be undertaken as a first step. Please beware of contractors who recommend expensive solutions. Excavation, damp-proofing and/or the installation of drainage tiles should be a last resort. In some cases, however, it is necessary. Your plans for using the basement may also influence the approach taken to curing any dampness that is experienced. A qualified basement waterproofing contractor needs to be consulted to further evaluate this condition and make the necessary repairs.

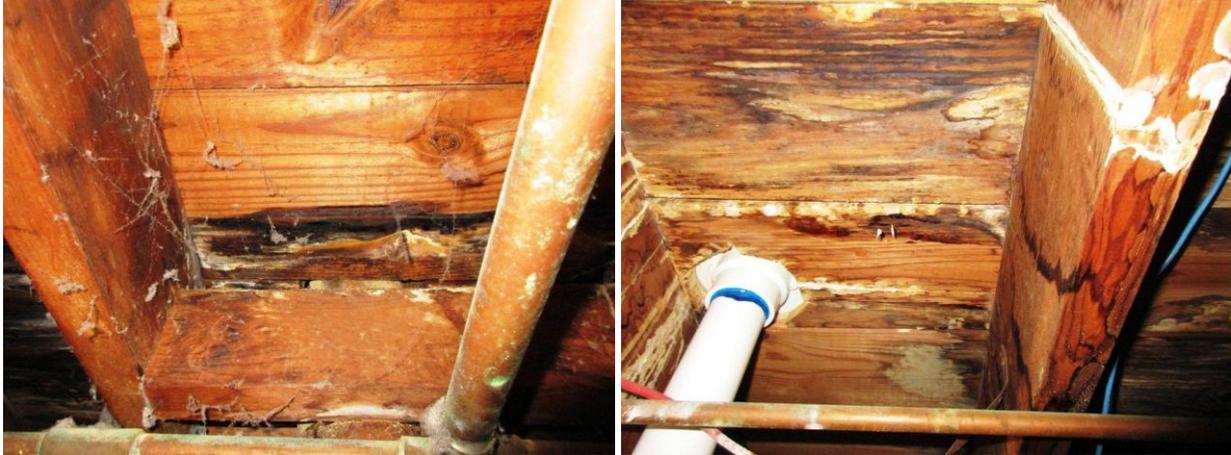
- **Repair:** Localized evidence of previous moisture damage was visible below both of the bathrooms. All moisture damaged wood needs to be replaced so as to prevent more serious damage in the future. A qualified contractor needs to be consulted to further evaluate this condition and make the necessary repairs. (It appears that plumbing repairs have been made).

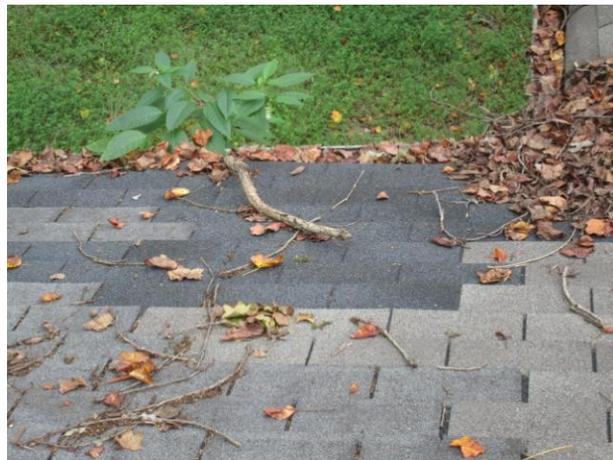
- **Major Concern, Repair:** The roofing is at the end of its life. Minor repairs might be possible to extend the roof life and to defer leaks. Damaged or missing roofing material should be repaired. All roof penetrations should be examined and sealed as necessary. Expect to replace the roof soon. The roof needs to be examined by a roofing contractor and repair/replacement cost estimated.
- **Repair:** Debris needs to be removed from the roofing to reduce risk of leaks and early roof wear.

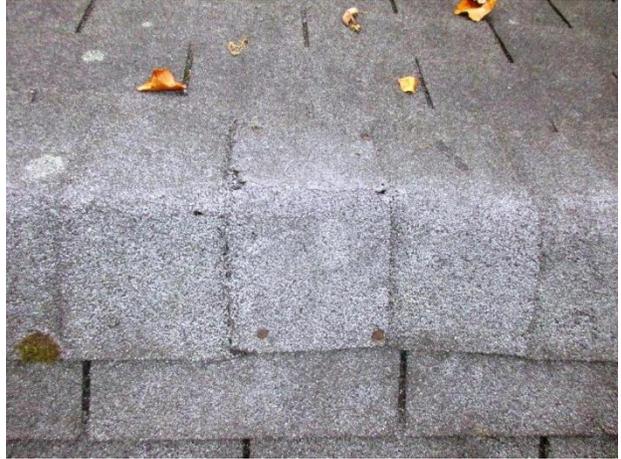
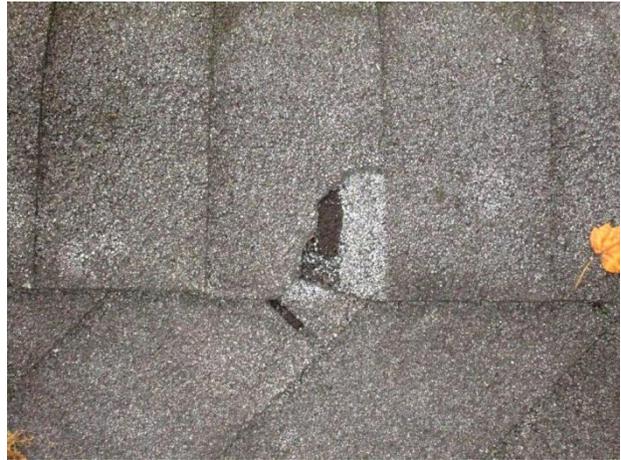
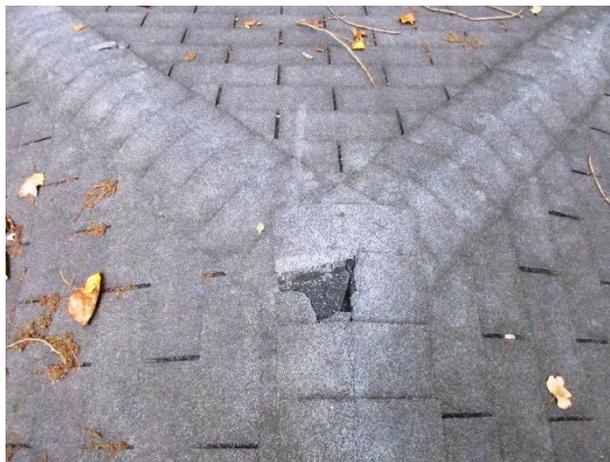
- **Repair:** Repairs to the roofing are needed. Damaged or missing shingles at the right and left ridge caps need to be replaced. All roof penetrations need to be examined and sealed as necessary. A qualified roofing contractor needs to be consulted to further evaluate this condition and make the necessary repairs.

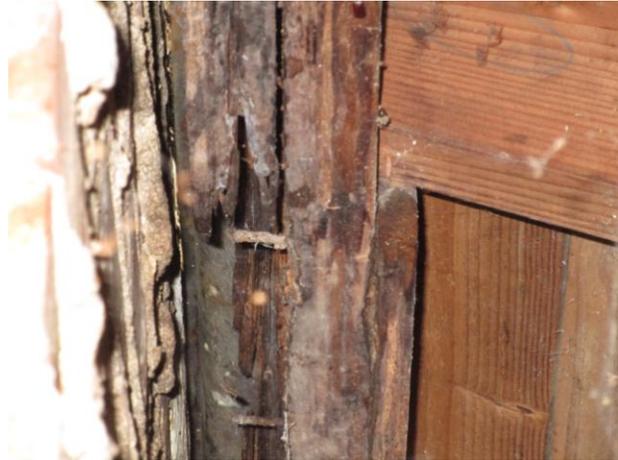
- **Repair:** Exposed nail heads were visible at all roofing penetrations. Damaged or missing roofing material needs to be repaired. A qualified roofing contractor needs to be consulted to further evaluate this condition and make the necessary repairs.
- **Major Concern, Repair:** The ridge in the attic at the front of the chimney shows signs of significant damage. (Light is visible from the interior). Damaged or missing flashing material needs to be repaired. A qualified roofing contractor needs to be consulted to further evaluate this condition and make the necessary repairs.

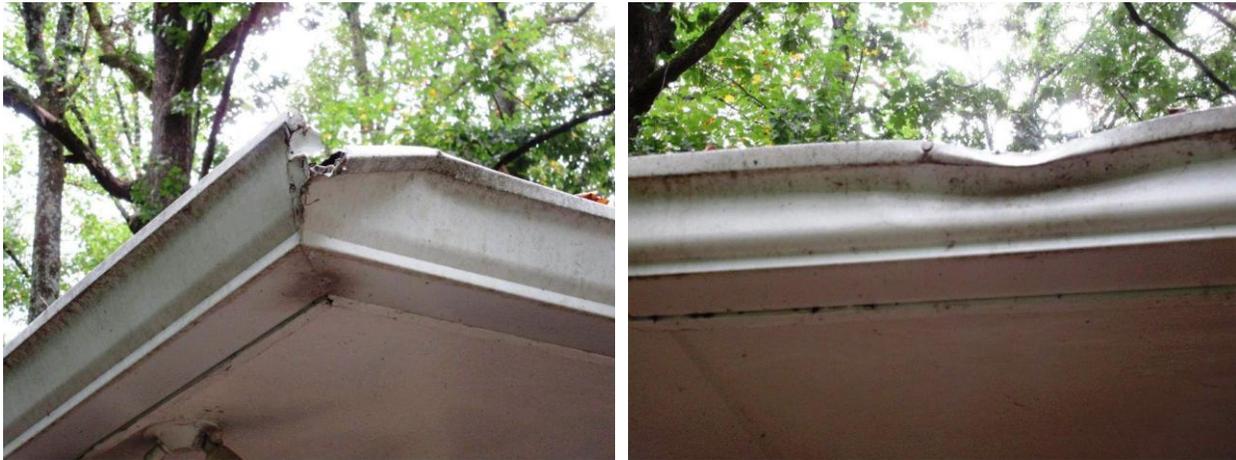
- **Repair:** The gutters at the right side and right rear side of the home need to be repaired or replaced as necessary to avoid spilling roof runoff around the building – a potential source of water entry or water damage. A qualified roofing or gutter contractor needs to be consulted to further evaluate this condition and make the necessary repairs.
