ITEM: Hammond Drive Property Assessment Update

# Hammond Drive Assessment Update

September 20, 2016

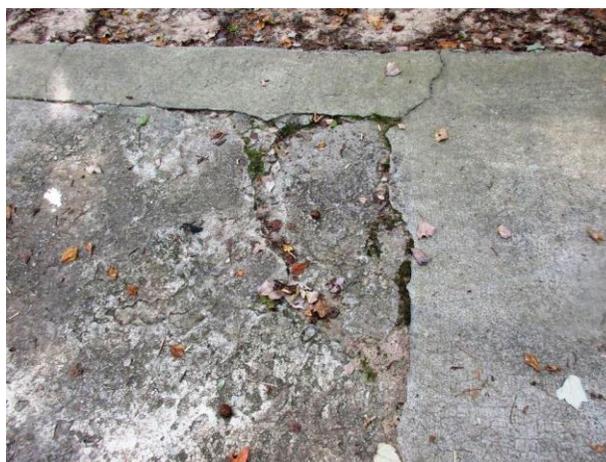
### Driveway

- **Major Concern:** The driveway surface is in a deteriorated condition. Resurfacing is necessary to correct this condition. A qualified concrete contractor needs to be consulted to further evaluate this condition and make the necessary repairs.

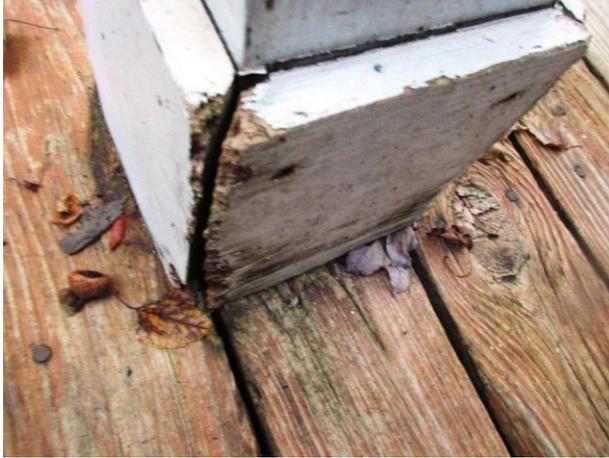
### Pergola

- **Repair:** The pergola trim shows evidence of substantial rot. All moisture damaged wood needs to be replaced so as to prevent more serious damage in the future. A qualified contractor needs to be consulted to further evaluate this condition and make the necessary repairs.

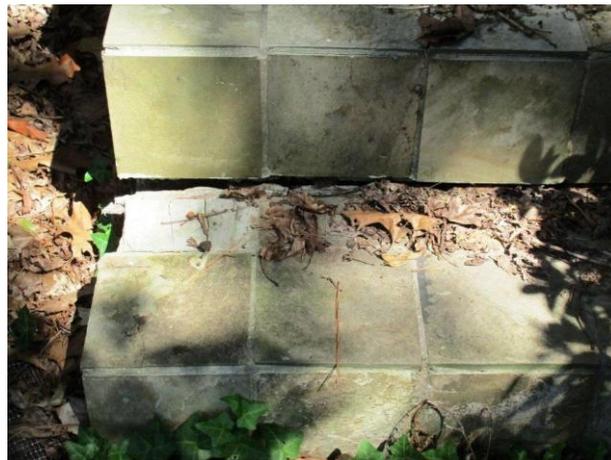
### Porch

- **Possible Major Concern, Repair:** The porch has settled relative to the house proper. This is a common condition that needs to be repaired. If the porch supports have not already been repaired, replacement may be needed. A qualified contractor needs to be consulted to further evaluate this condition and make the necessary repairs.

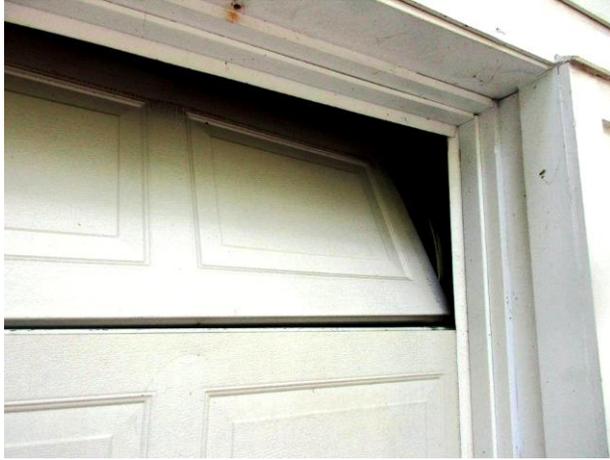
### Garage

- **Repair, Safety Issue:** The left and right overhead garage doors are damaged and need repair. A qualified garage door technician needs to be consulted to further evaluate this condition and make the necessary repairs. **Note:** The detached garage was inaccessible at the time of the inspection.

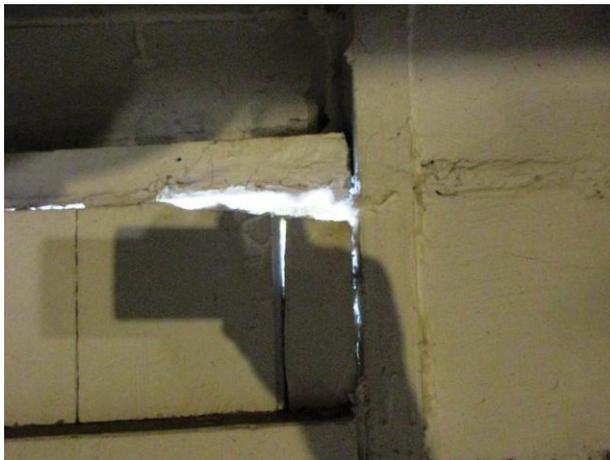
- **Repair:** It is recommended that the basement door be replaced with a proper exterior door and that all gaps to the exterior be completely sealed. A qualified contractor needs to be consulted to further evaluate this condition and make the necessary repairs.

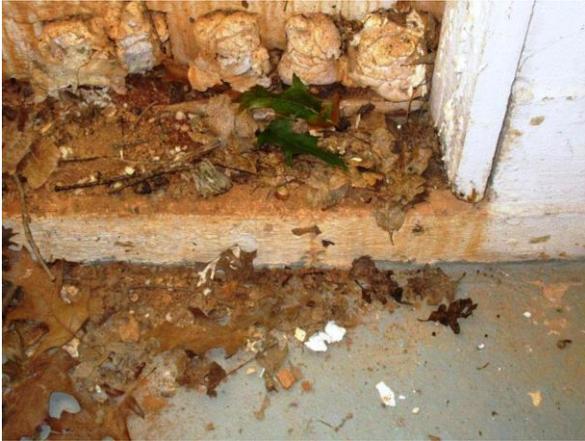
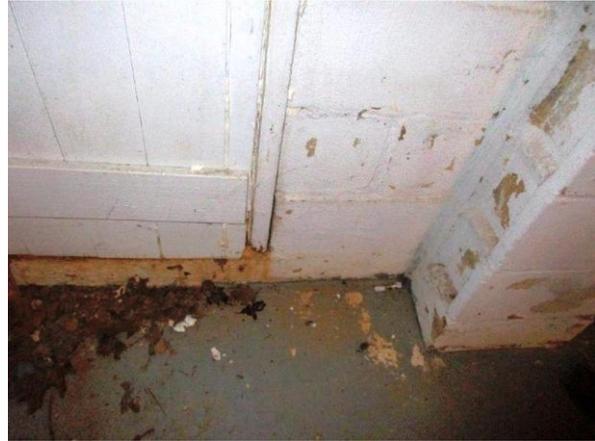
- **Repair:** Localized evidence of moisture intrusion was visible at the basement exterior door. A qualified contractor needs to be consulted to further evaluate this condition and make the necessary repairs.

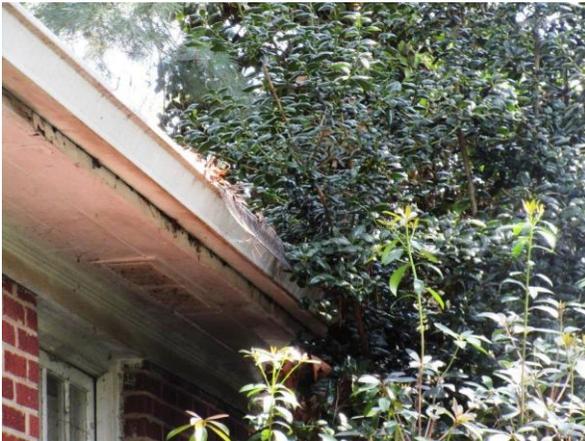
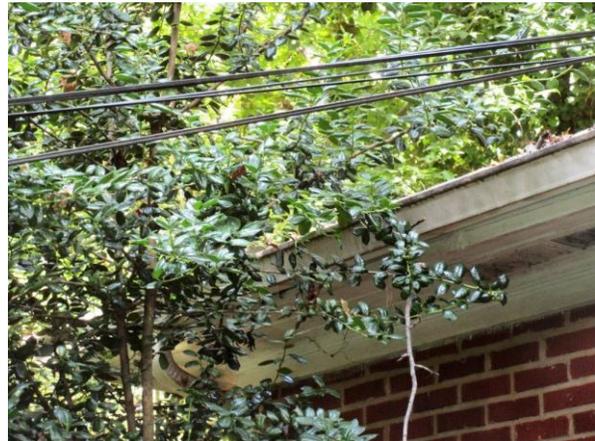
### Landscaping

- **Repair:** Tree branches need to be trimmed away from the house to avoid damage to the exterior of the home.

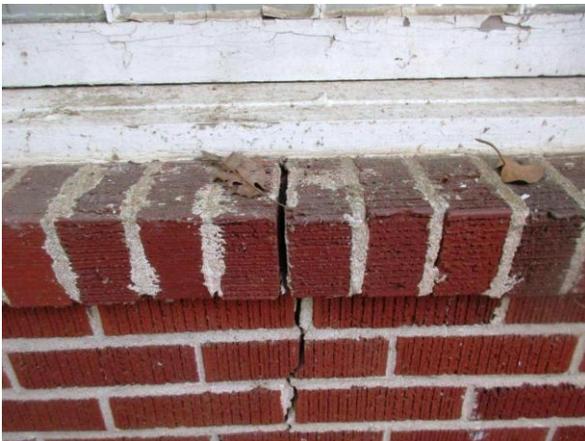
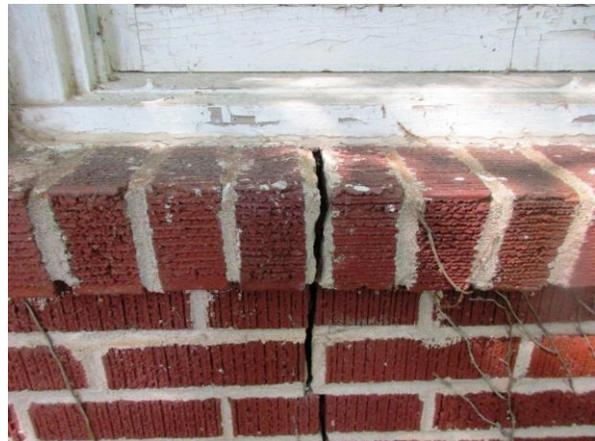
### Windows

- **Repair:** The exterior brickwork at the window ledge of the rear window, the rear bedroom window, and the right side window needs to be re-pointed (replacement of the mortar between the bricks) to prevent further deterioration.

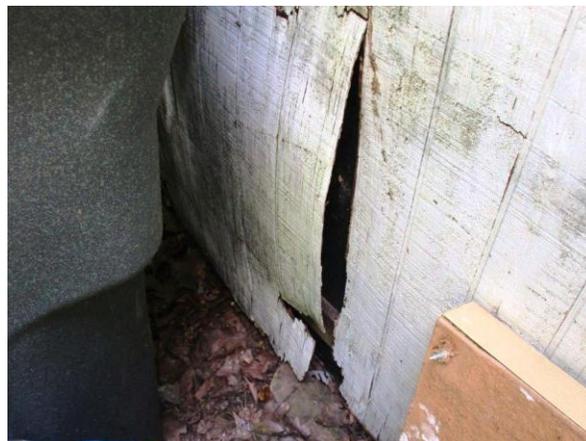
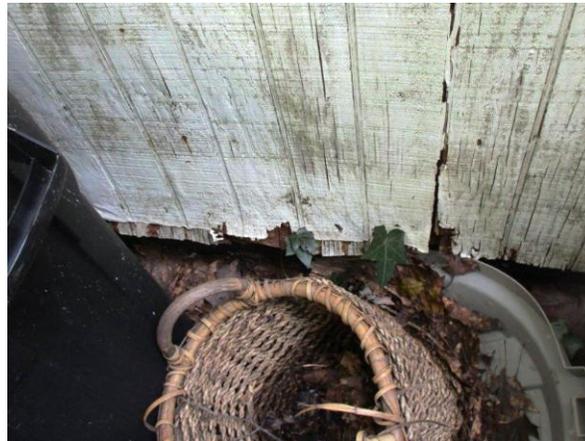
#### Exterior Walls

- **Repair:** The exterior of the home needs to be painted to preserve the building materials.
- **Repair:** Wood/soil contact at the base of the garage siding needs to be eliminated. Rotted or damaged siding that is uncovered needs to be repaired. These areas are at risk of additional hidden damage.

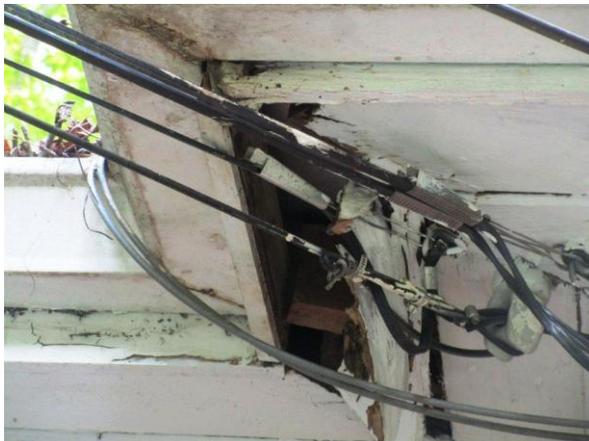
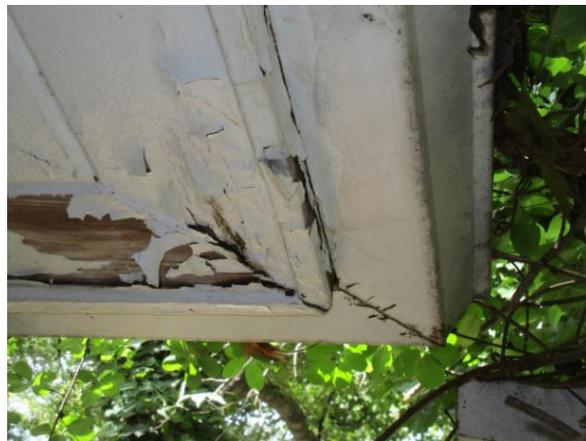
### Exterior Eaves

- **Repair:** The fascia at the rear of the pergola and the front and rear soffits show evidence of substantial rot. Repair or replacement is needed. A qualified contractor needs to be consulted to further evaluate this condition and make the necessary repairs.
- **Repair:** Significant damage to the front soffit at the incoming telephone and cable lines was noted. Repair or replacement is needed. A qualified contractor needs to be consulted to further evaluate this condition and make the necessary repairs.

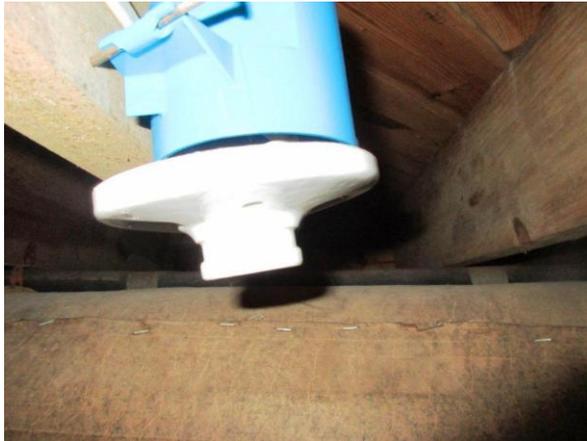
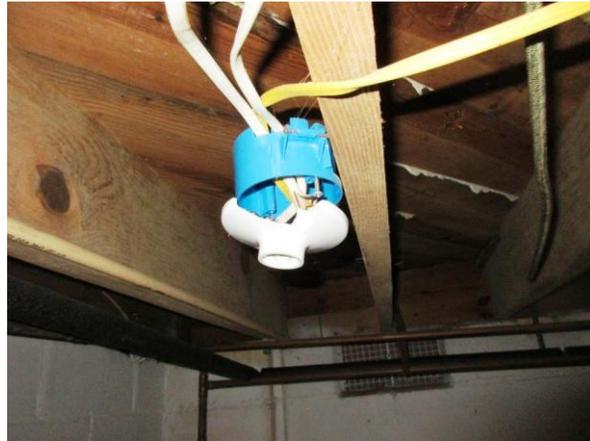
- **Repair:** Several of the light fixtures in the basement are loose/damaged and need to be repaired or replaced.

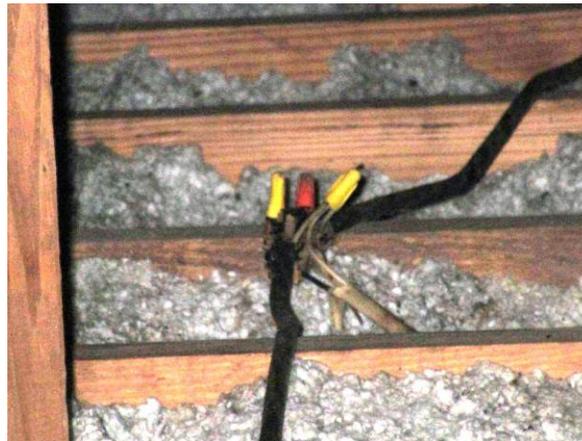
- **Repair:** The splices in the left and right attic need to be fitted with junction boxes to prevent a shock hazard.

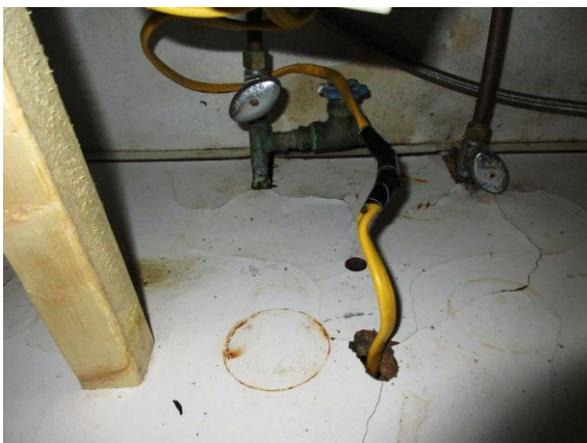
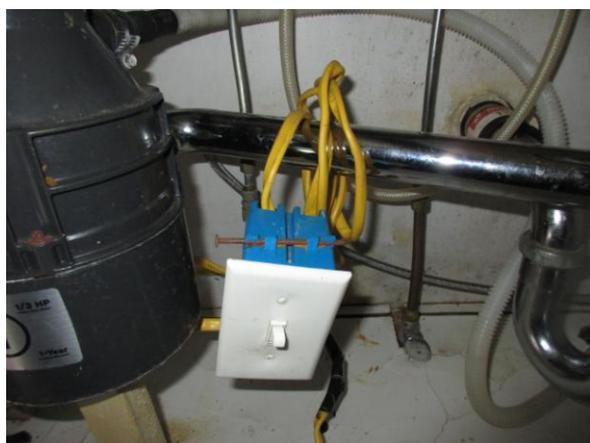
- **Repair:** The installation of junction boxes is recommended for the splices below the kitchen sink.
- **Repair:** The loose switch for the garbage disposal needs to be properly secured.

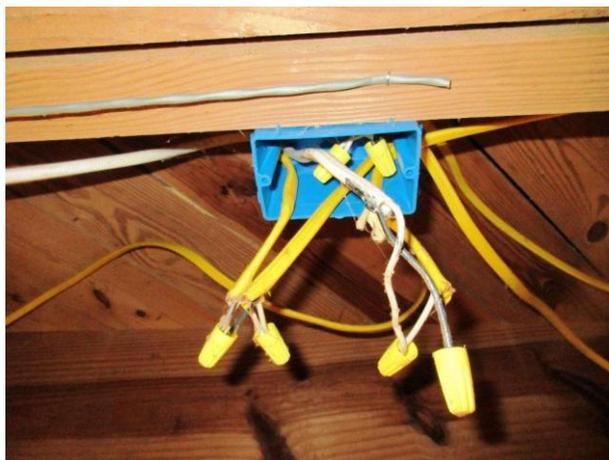
- **Repair:** The junction box near the middle right of the subfloor area needs to be fitted with a cover plate in order to protect the wire connections.

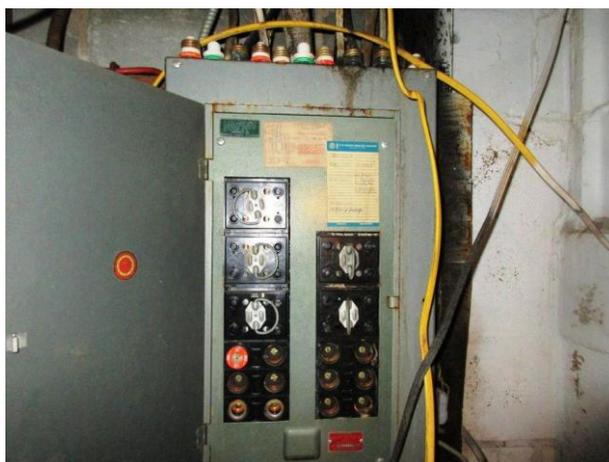
#### Main Panel

- **Monitor:** The main distribution panel shows evidence of rusting, due to dripping water. This condition needs to be improved. If rusting continues, or if moisture is evident in the vicinity of the panel, an electrician needs to be consulted.
- **Safety Issue:** The main service panel cover was not removed due to standing water.

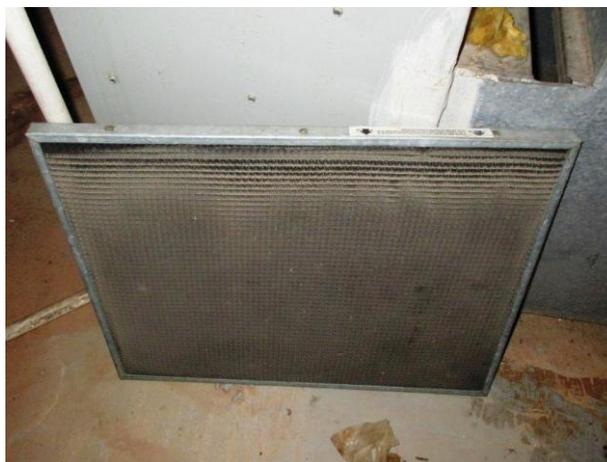
### Furnace

- **Repair:** The dirty air filter for the furnace needs to be cleaned.

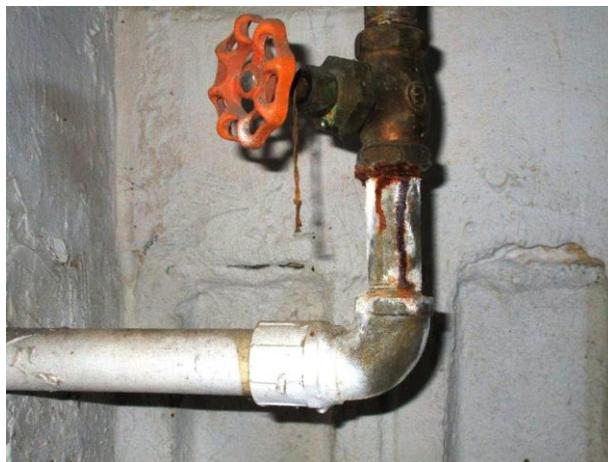
- **Repair:** A shut off valve is needed for the dishwasher water supply line. A qualified plumber needs to be consulted to further evaluate this condition and make the needed repairs.
- **Repair:** The incoming water supply line is leaking and needs repair. A qualified plumber needs to be consulted to further evaluate this condition and make the needed repairs.

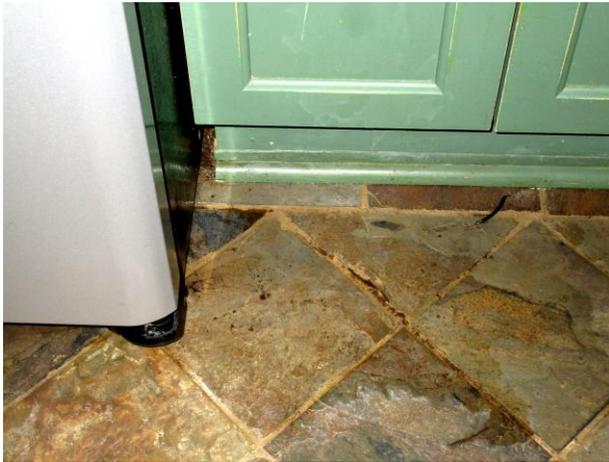
- **Major Concern, Repair:** The supply piping is leaking is leaking below the refrigerator. This has resulted in significant standing water in the basement and subfloor below the kitchen. A qualified contractor needs to be consulted to further evaluate this condition and make the necessary repairs.

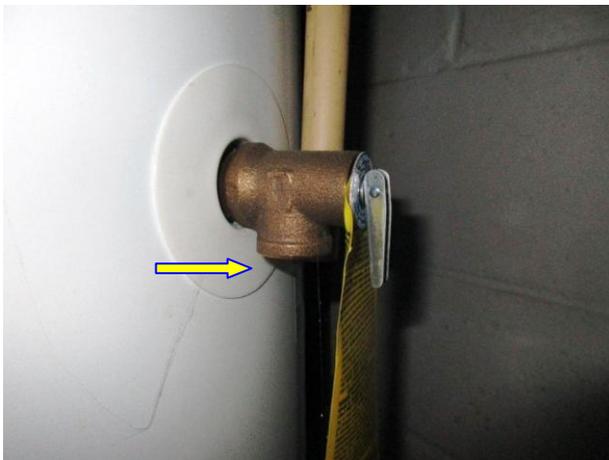
### Water Heater

- **Repair:** The discharge piping serving the Temperature and Pressure Relief (TPR) Valve for the water heater is not properly plumbed. A qualified plumber needs to be consulted to further evaluate this condition and make the necessary repairs.
- **Repair, Safety Issue:** The water heater is missing the secondary expansion valve or tank. This has been a requirement since 1998. A qualified plumber needs to be consulted to further evaluate this condition and make the necessary repairs. Additional information about secondary expansion tanks can be found at: <http://www.watts.com/pages/learnAbout/thermalExpansion.asp?catId=64>

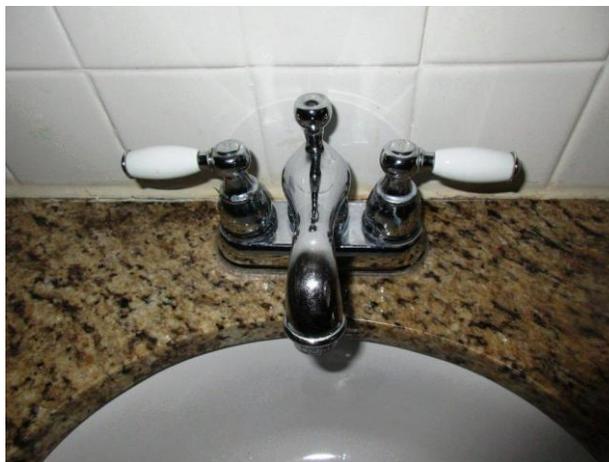
### Fixtures

- **Repair:** The hallway bathroom toilet is loose and needs to be further secured.
- **Repair:** The hallway bathroom sink is loose and needs to be further secured.

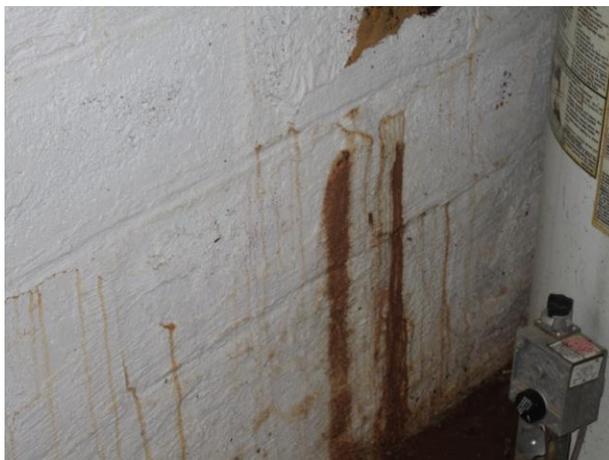
### Basement Leakage

- Monitor:** The left rear basement shows evidence of moisture penetration. *It should be understood that it is impossible to predict the severity or frequency of moisture penetration on a one-time visit to a home.* Virtually all basements exhibit signs of moisture penetration and virtually all basements will indeed leak at some point in time. The visible evidence is not unusual for a home of this age, construction and location. Further monitoring of the foundation will be required to determine what improvements, if any, will be required. Basement leakage rarely affects the structural integrity of a home. The vast majority of basement leakage problems are the result of insufficient control of storm water at the surface. The ground around the house should be sloped to encourage water to flow away from the foundations. Gutters and downspouts should act to collect roof water and drain the water at least five (5) feet from the foundation or into a functional storm sewer. Downspouts that are clogged or broken below grade level, or that discharge too close to the foundation are the most common source of basement leakage. Please refer to the Roofing and Exterior sections of the report for more information. In the event that basement leakage problems are experienced, lot and roof drainage improvements should be undertaken as a first step. Please beware of contractors who recommend expensive solutions. Excavation, damp-proofing and/or the installation of drainage tiles should be a last resort. In some cases, however, it is necessary. Your plans for using the basement may also influence the approach taken to curing any dampness that is experienced.

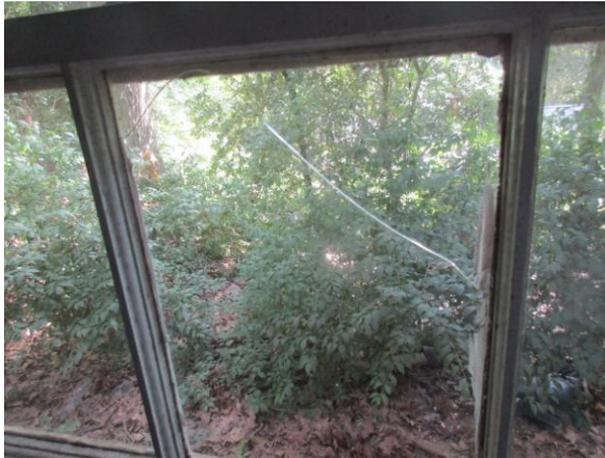
### Windows

- **Repair:** One of the right rear bedroom windows is cracked and needs to be replaced. A qualified contractor needs to be consulted to further evaluate this condition and make the necessary repairs.
- **Repair:** The window lock keeper for the hall bathroom is missing and needs to be replaced. A qualified contractor needs to be consulted to further evaluate this condition and make the necessary repairs.

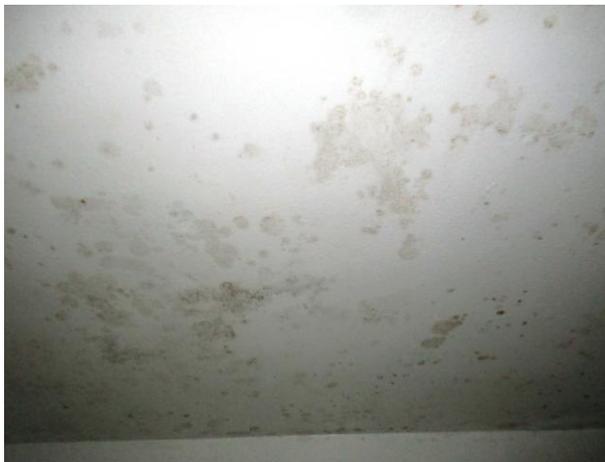
### Wall / Ceiling Finishes

- **Repair:** Signs of mildew were observed in the hall bathroom and bathroom closet. Cleaning with a mildewcide is needed.

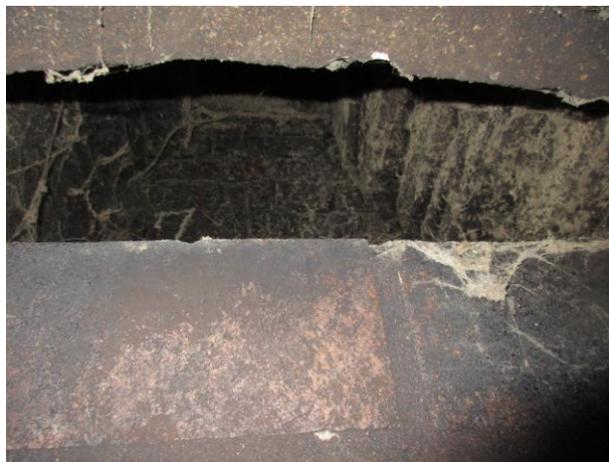
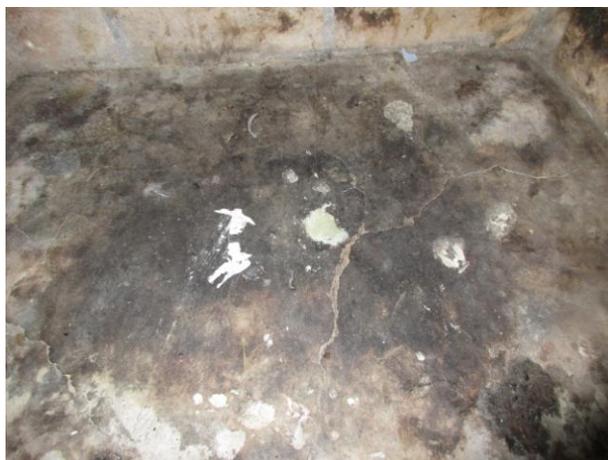
#### Fireplaces

- **Repair:** The fireplace chimney needs to be cleaned and inspected prior to operation. A qualified chimney sweep contractor needs to be consulted to further evaluate this condition and make the necessary repairs.
- **Repair:** The fireplace damper is missing and needs to be replaced. A qualified contractor needs to be consulted to further evaluate this condition and make the necessary repairs.
- **Repair, Safety Issue:** The floor of the fireplace firebox needs to be repaired for improved safety. A qualified contractor needs to be consulted to further evaluate this condition and make the necessary repairs.

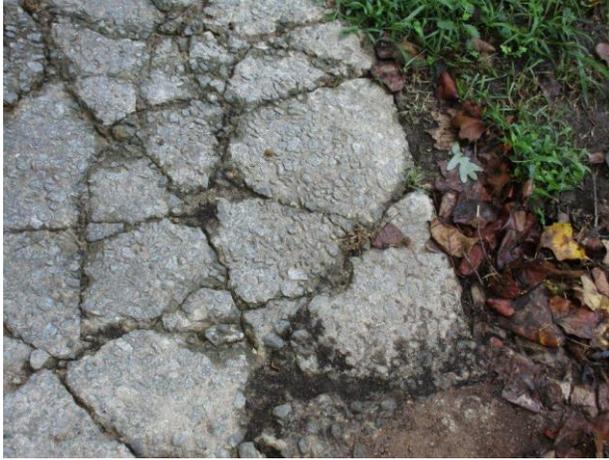
- **Major Concern, Repair:** The driveway surface is in a deteriorated condition. Resurfacing is necessary to correct this condition. A qualified concrete contractor needs to be consulted to further evaluate this condition and make the necessary repairs. (Trip hazards).

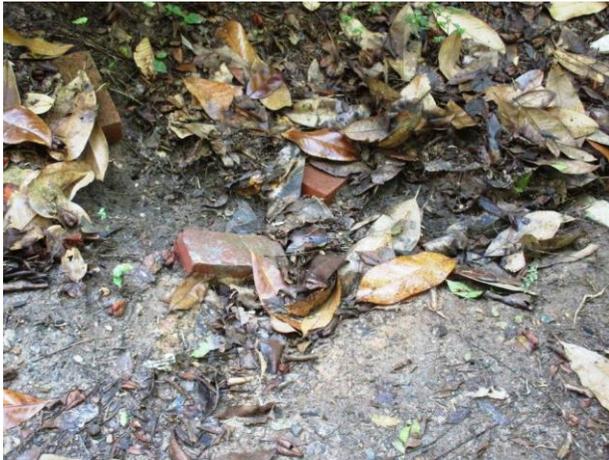
- **Repair:** The grading of the soil at the front and right side of the home needs to be altered for improved erosion control. A qualified landscaping contractor needs to be consulted to further evaluate this condition and make the necessary repairs.

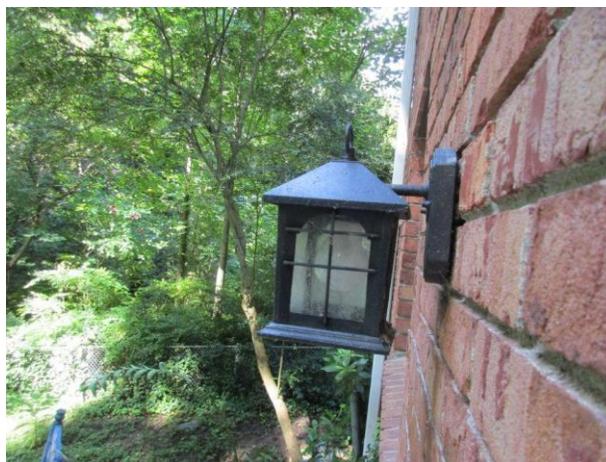
- **Repair:** The loose light fixture in the basement needs to be repaired or replaced.
- **Repair:** The patio door light and the front flood lights were inoperative. If the bulbs are not blown, the circuits need to be repaired.

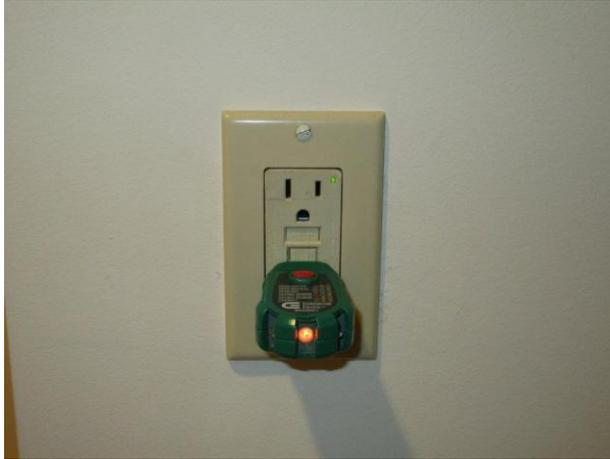
- **Repair:** The upper level bathroom outlet, the front master bedroom outlet, and the right front master bedroom outlet tested with open ground. Ungrounded 3-prong outlets need to be repaired. In some cases a ground wire may be present in the electrical box and simply needs to be connected. If no ground is present “repair” can be as simple as filling the ground slot with epoxy. Better, since having a ground increases safety, a grounded circuit could be strung to this outlet, or a separate ground wire could be connected. Some electrical codes allow the installation of a ground fault circuit interrupter (GFCI) type outlet where grounding is not provided. In this case the GFCI may work but can’t be tested by normal means.
- **Repair:** A receptacle for the electric range needs to be installed.

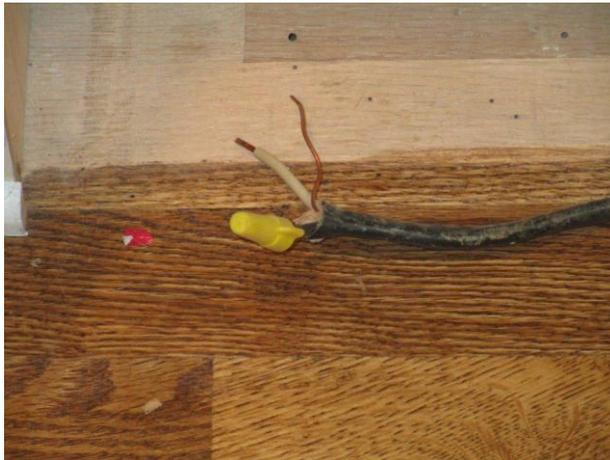
- **Repair, Safety Issue:** A junction box needs to be installed and covered for the dishwasher electrical supply.

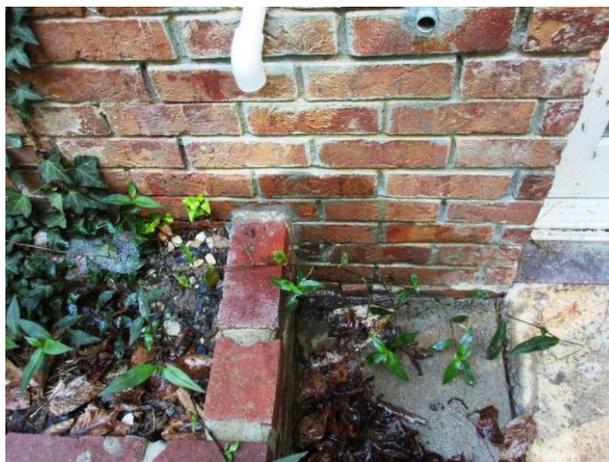
- **Monitor:** As is not uncommon for homes of this age and location, the air conditioning system is older. It may require a slightly higher level of maintenance, and may be more prone to major component breakdown. Predicting the frequency or time frame for repairs on any mechanical device is virtually impossible.
- **Repair:** The air conditioning condensate line needs to be altered to extend away from the home. A qualified heating and cooling technician needs to be consulted to further evaluate this condition and make the necessary repairs.

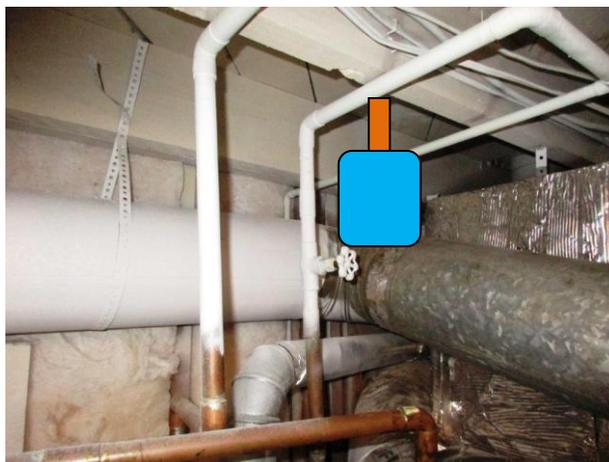
- **Monitor:** Water heaters have a typical life expectancy of 7 to 12 years. The existing unit is in this age range. One cannot predict with certainty when replacement will become necessary.
- **Repair, Safety Issue:** The water heater is missing the secondary expansion valve or tank. This has been a requirement since 1998. A qualified plumber needs to be consulted to further evaluate this condition and make the necessary repairs. Additional information about secondary expansion tanks can be found at: <http://www.watts.com/pages/learnAbout/thermalExpansion.asp?catId=64>

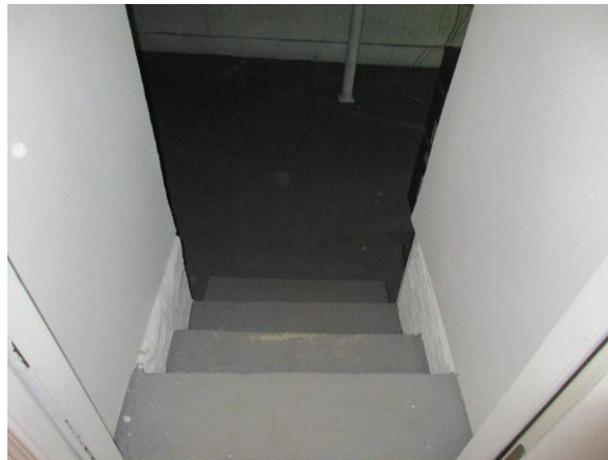
- **Repair, Safety Issue:** For improved safety, it is recommended that a handrail be provided for the stairway leading to the basement.

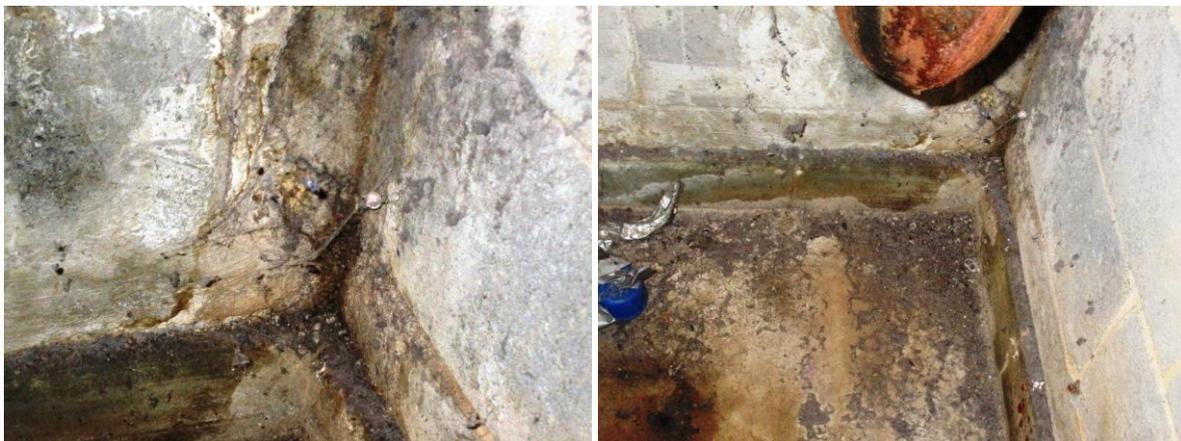
- Repair:** The right rear of the basement shows evidence of active moisture penetration. *It should be understood that it is impossible to predict the severity or frequency of moisture penetration on a one-time visit to a home.* Virtually all basements exhibit signs of moisture penetration and virtually all basements will indeed leak at some point in time. The visible evidence is not unusual for a home of this age, construction and location. Further monitoring of the foundation will be required to determine what improvements, if any, will be required. Basement leakage rarely affects the structural integrity of a home.

The vast majority of basement leakage problems are the result of insufficient control of storm water at the surface. The ground around the house should be sloped to encourage water to flow away from the foundations. Gutters and downspouts should act to collect roof water and drain the water at least five (5) feet from the foundation or into a functional storm sewer. Downspouts that are clogged or broken below grade level, or that discharge too close to the foundation are the most common source of basement leakage. Please refer to the Roofing and Exterior sections of the report for more information. In the event that basement leakage problems are experienced, lot and roof drainage improvements should be undertaken as a first step. Please beware of contractors who recommend expensive solutions. Excavation, damp-proofing and/or the installation of drainage tiles should be a last resort. In some cases, however, it is necessary. Your plans for using the basement may also influence the approach taken to curing any dampness that is experienced.

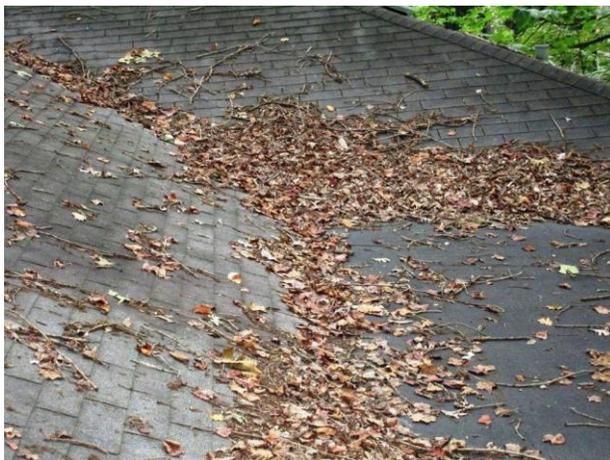
- **Major Concern, Repair:** The roofing is at the end of its life. Minor repairs might be possible to extend the roof life and to defer leaks. Damaged or missing roofing material should be repaired. All roof penetrations should be examined and sealed as necessary. Expect to replace the roof soon. The roof needs to be examined by a roofing contractor and repair/replacement cost estimated.
- **Repair:** Debris needs to be removed from the roofing to reduce risk of leaks and early roof wear.

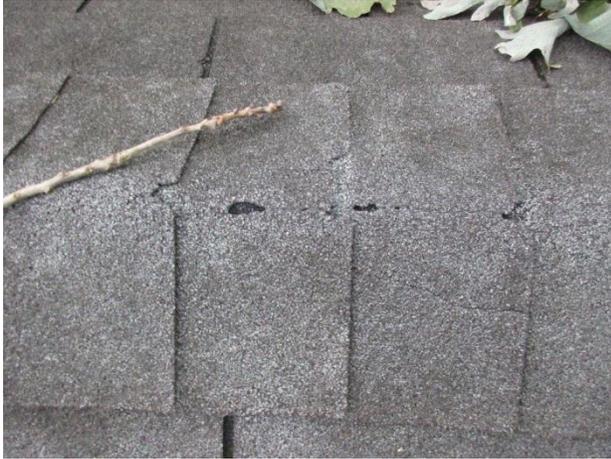
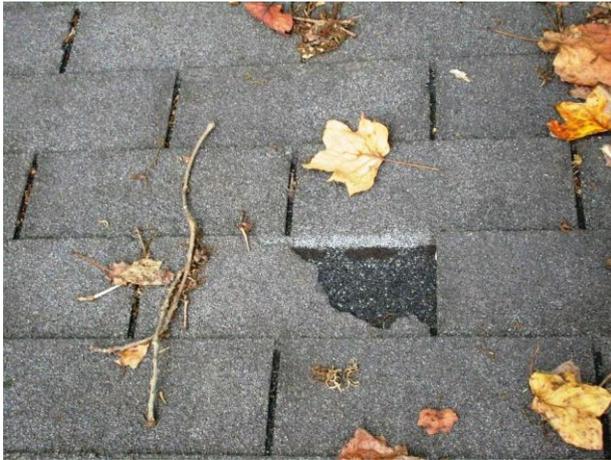
- **Repair:** Repairs to the roofing are needed. Damaged or missing shingles at the right and left ridge caps need to be replaced. All roof penetrations need to be examined and sealed as necessary. A qualified roofing contractor needs to be consulted to further evaluate this condition and make the necessary repairs.

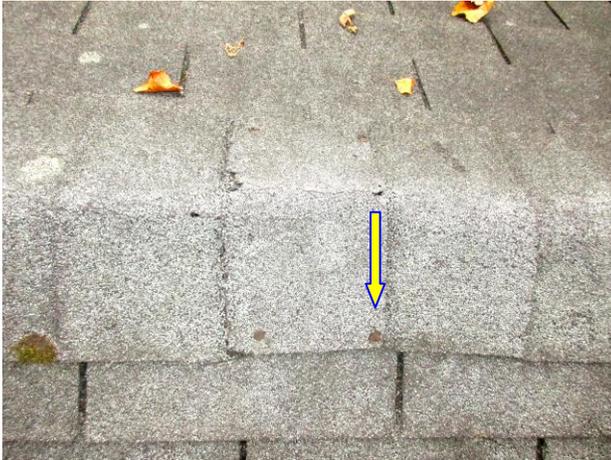
- **Repair:** Exposed nail heads were visible at all roofing penetrations. Damaged or missing roofing material needs to be repaired. A qualified roofing contractor needs to be consulted to further evaluate this condition and make the necessary repairs.
- **Major Concern, Repair:** The ridge in the attic at the front of the chimney shows signs of significant damage. (Light is visible from the interior). Damaged or missing flashing material needs to be repaired. A qualified roofing contractor needs to be consulted to further evaluate this condition and make the necessary repairs.

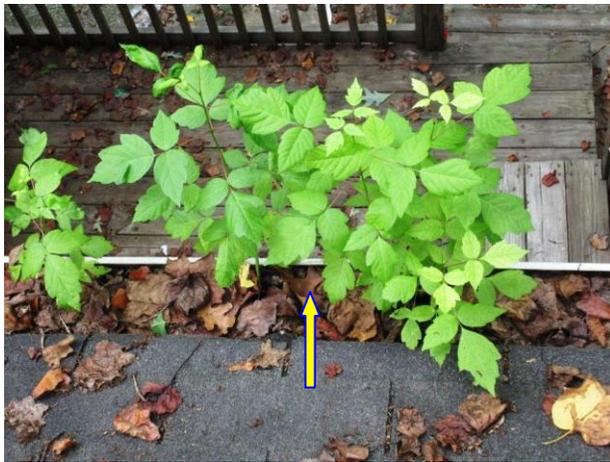
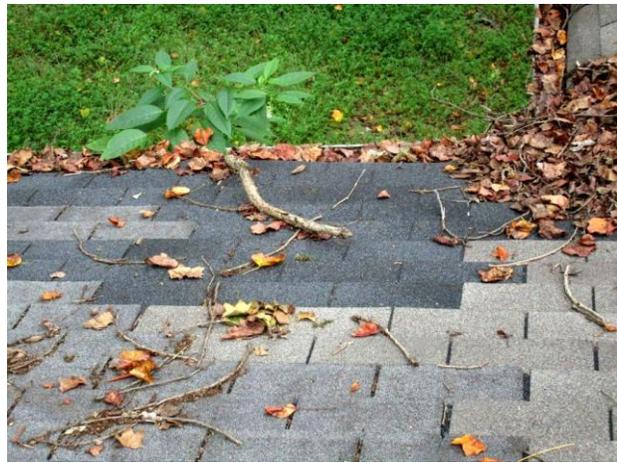
- **Repair:** The gutters require cleaning to avoid spilling roof runoff around the building – a potential source of water entry or water damage. **Note:** Extreme caution needs to be used when cleaning; the plants growing out of the gutters at the rear of the roof is Poison Ivy.

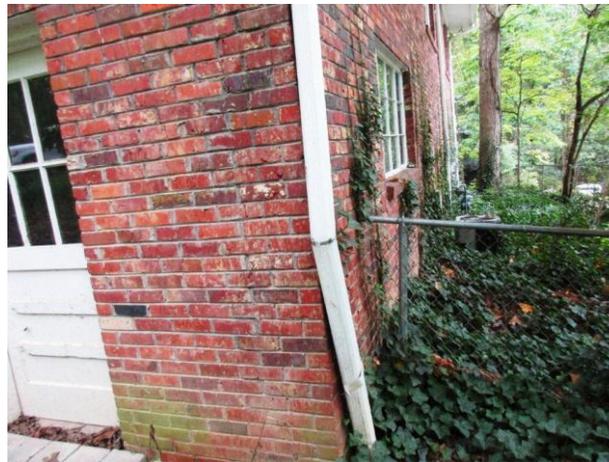
- **Repair:** The left rear downspout is damaged and needs to be repaired. A qualified roofing or gutter contractor needs to be consulted to further evaluate this condition and make the necessary repairs.

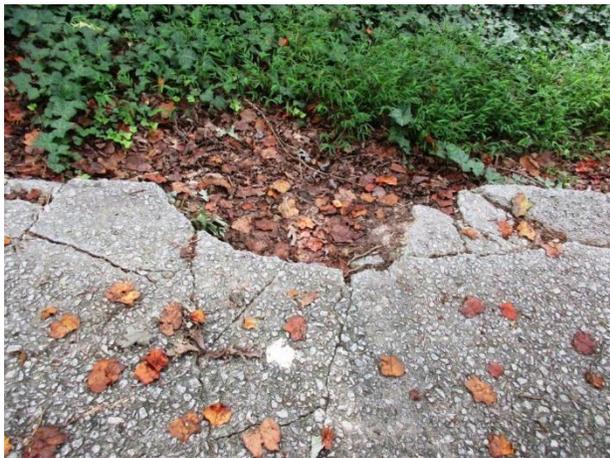
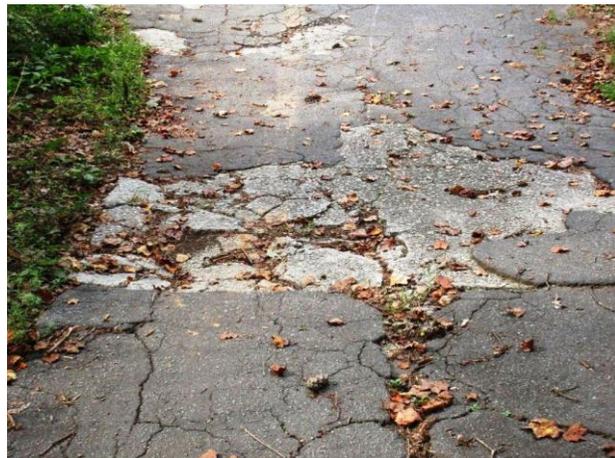
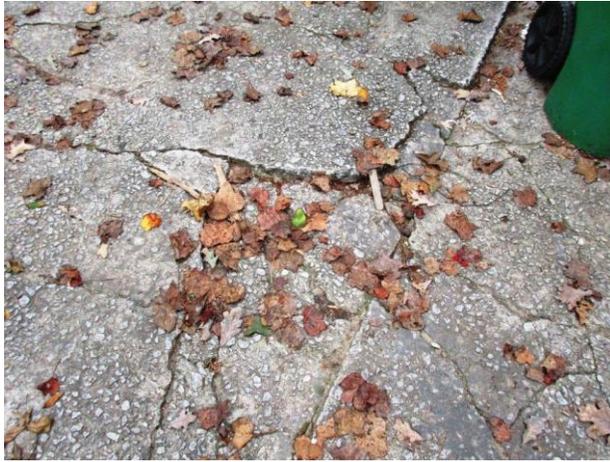
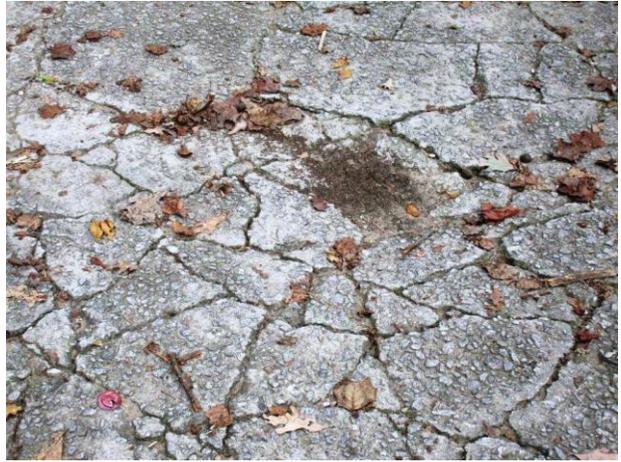
- **Major Concern, Repair:** The surface of the driveway and rear parking area is in a deteriorated condition. Resurfacing is necessary to correct this condition. A qualified concrete contractor needs to be consulted to further evaluate this condition and make the necessary repairs.

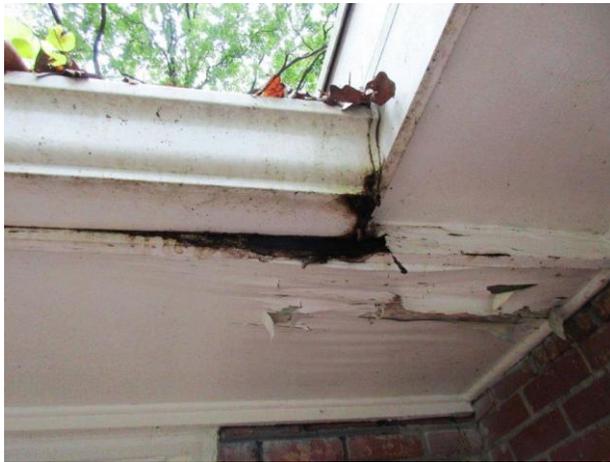
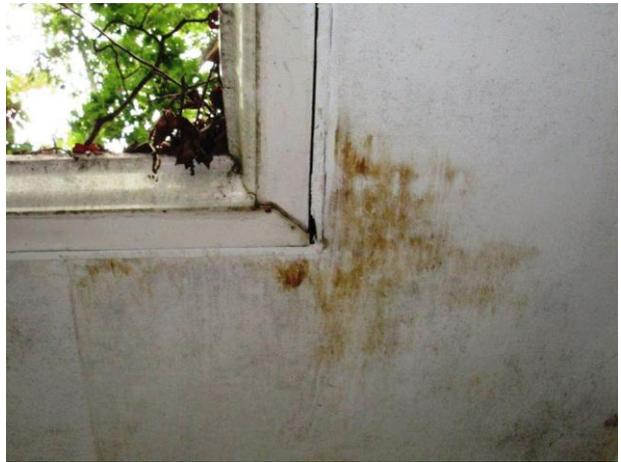
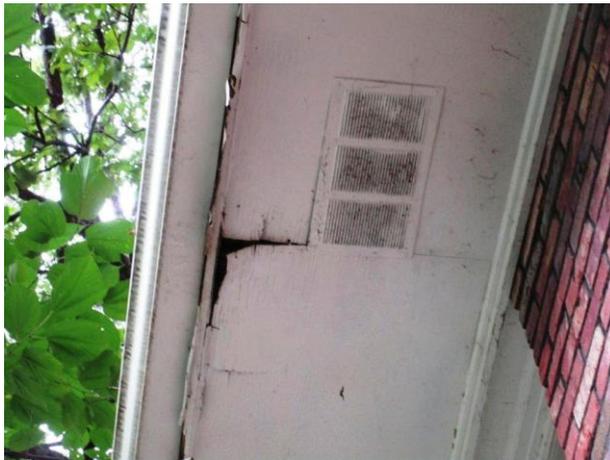
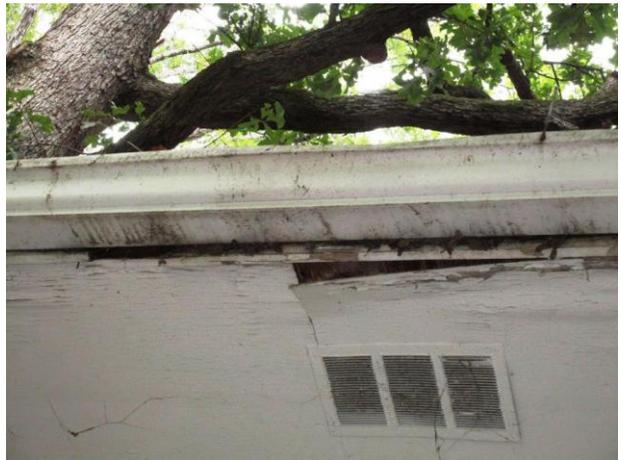
- **Repair:** The fascia and soffits above the deck at the rear of the home, at the right front corner of the home above the porch, and at the left side of home show evidence of substantial rot. All moisture damaged wood needs to be replaced so as to prevent more serious damage in the future. A qualified contractor needs to be consulted to further evaluate this condition and make the necessary repairs.

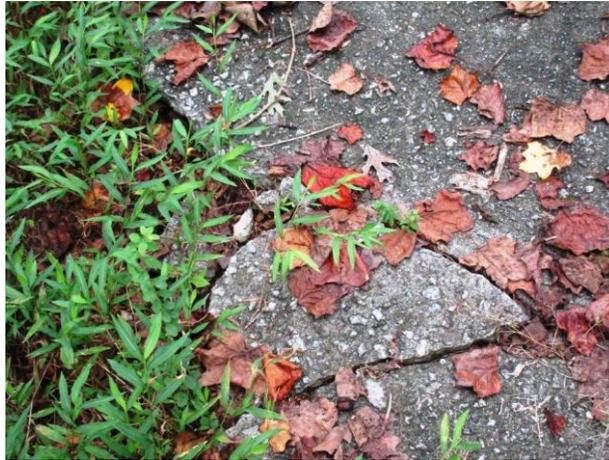
- **Repair, Safety Issue:** The front walkway presents a trip hazard. This condition needs to be altered for improved safety. A qualified concrete contractor needs to be consulted to further evaluate this condition and make the necessary repairs.

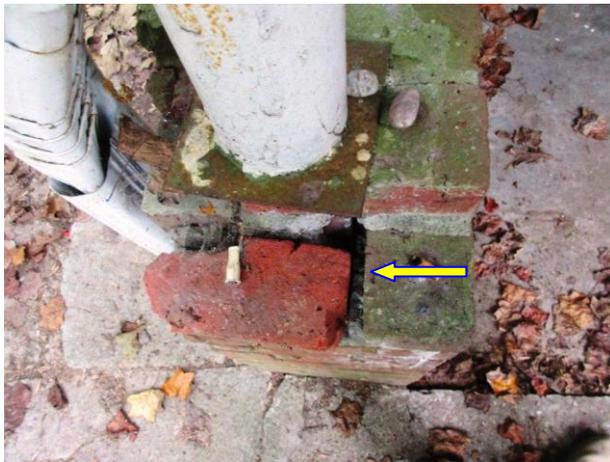
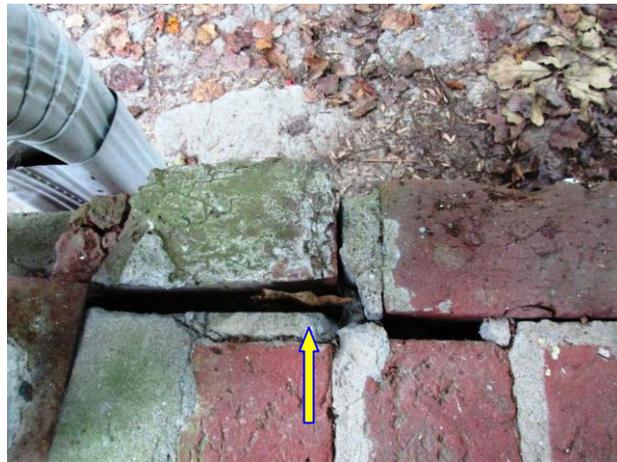
- **Repair:** The loose/damaged brickwork at the carport support wall needs to be repaired to avoid movement in the support structure.

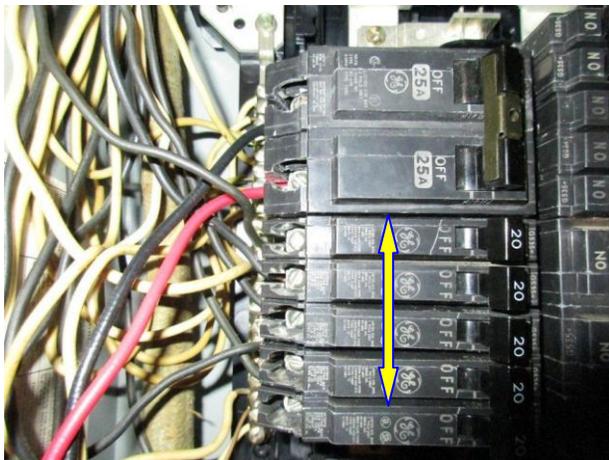
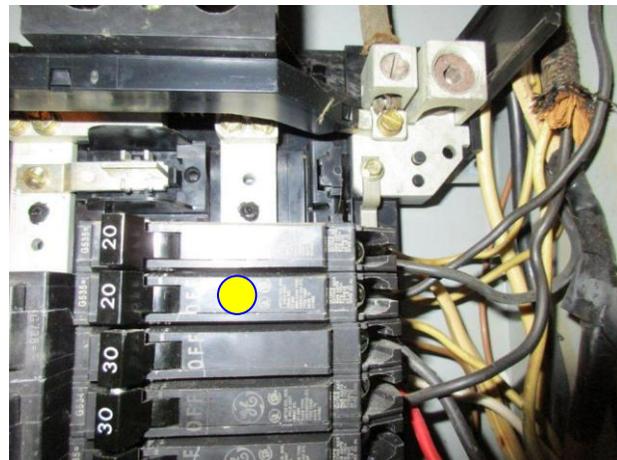
- **Repair, Safety Issue:** The oversized twenty (20) amp breakers at the top left and top right side of the main distribution panel need to be replaced. All breakers serving household branch circuits should be sized at fifteen (15) amps when connected to 14 gauge wire.

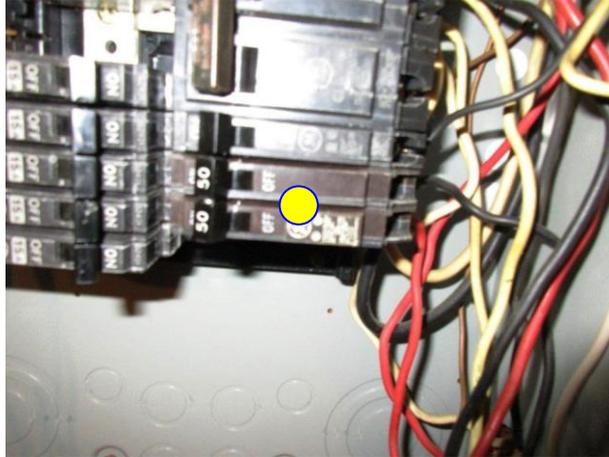
- **Major Concern, Repair:** The main distribution panel is an outdoors type panel used for main disconnects and is not appropriate for a load center with multiple circuit breakers. This panel needs to be replaced with an appropriate load center. be replaced.
- **Repair:** The oversized fifty (50) amp breaker at the bottom right of the main distribution panel needs to be replaced. The breaker serving this household branch circuits should be sized at 30 amps due to the size 10 wire.
