ITEM: Hammond Drive Property Assessment Update

# Hammond Drive Assessment Update

September 20, 2016

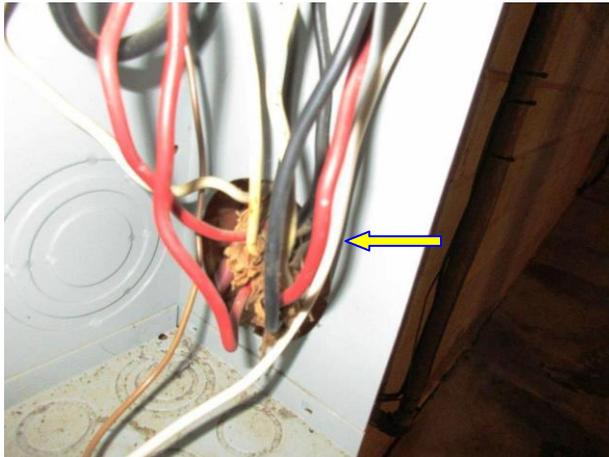
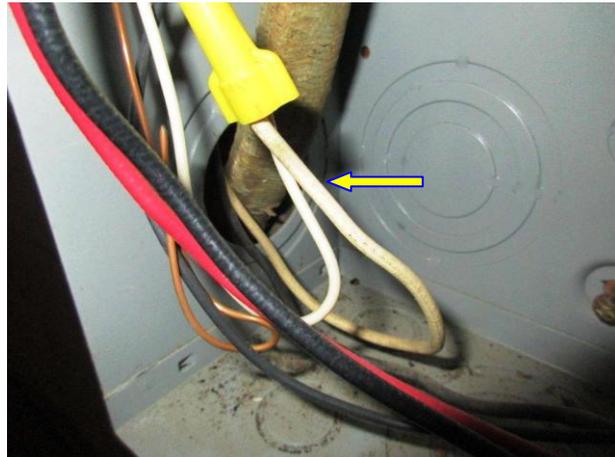
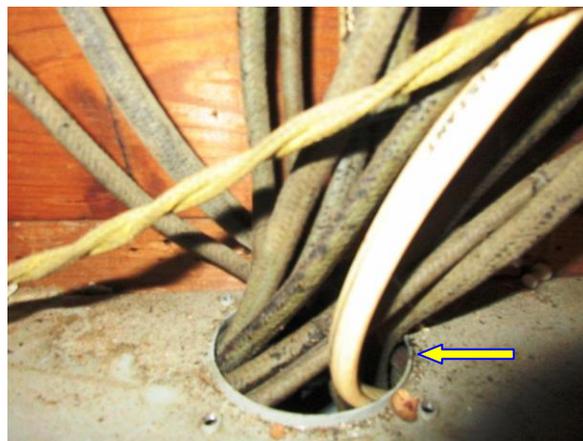
- **Repair:** Cable clamps (sometimes referred to as bushings or grommets) are required at the right, left, and top of the panel where wiring passes into the main distribution panel. Cable clamps serve to protect the wiring from the metal edges of the panel openings.

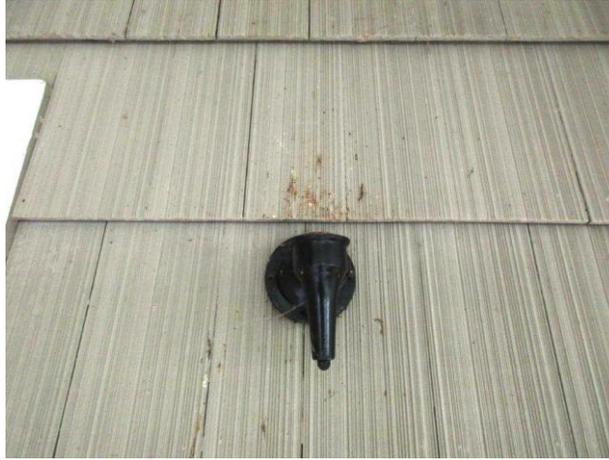
- **Repair:** The light in the left rear bedroom, the right rear flood lights, and the front porch light were inoperative at the time of this inspection. If the bulbs are not blown, then the circuits need to be repaired.

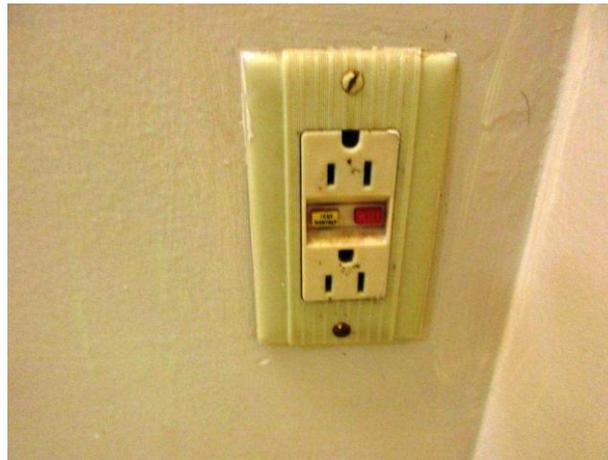
- **Repair:** The ungrounded 3-prong outlet in the left front bedroom needs to be repaired. In some cases a ground wire may be present in the electrical box and simply needs to be connected. If no ground is present “repair” can be as simple as filling the ground slot with epoxy. Better, since having a ground increases safety, a grounded circuit could be strung to this outlet, or a separate ground wire could be connected. Some electrical codes allow the installation of a ground fault circuit interrupter (GFCI) type outlet where grounding is not provided. In this case the GFCI may work but can’t be tested by normal means.
- **Repair:** The ground fault circuit interrupter (GFCI) outlets in the Jack and Jill bathroom and the hallway bathroom did not respond correctly to testing during the inspection. These receptacles need to be replaced.

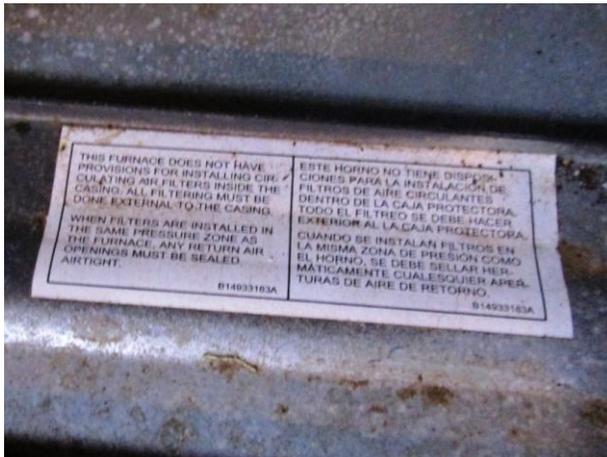
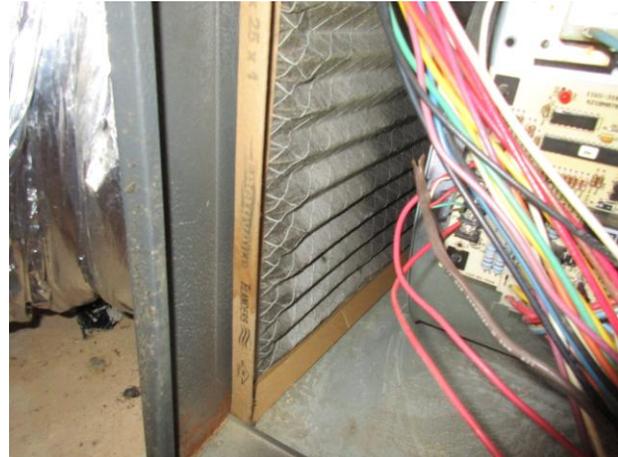
- **Repair:** As the thermostat was inoperative, the furnace could not be tested at the time of the inspection. The heating system requires service. This should be a regular maintenance item to assure safe, reliable heat. A qualified heating and cooling technician needs to be consulted to further evaluate the condition of the furnace and make the necessary repairs.
- **Repair:** The furnace requires an exterior filter frame. A qualified heating and cooling technician needs to be consulted to further evaluate this condition and make the necessary repairs.

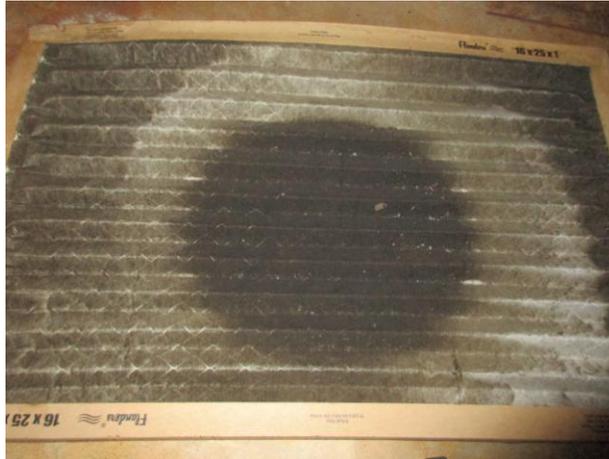
- **Repair:** The dirty air filter for the furnace needs to be replaced.

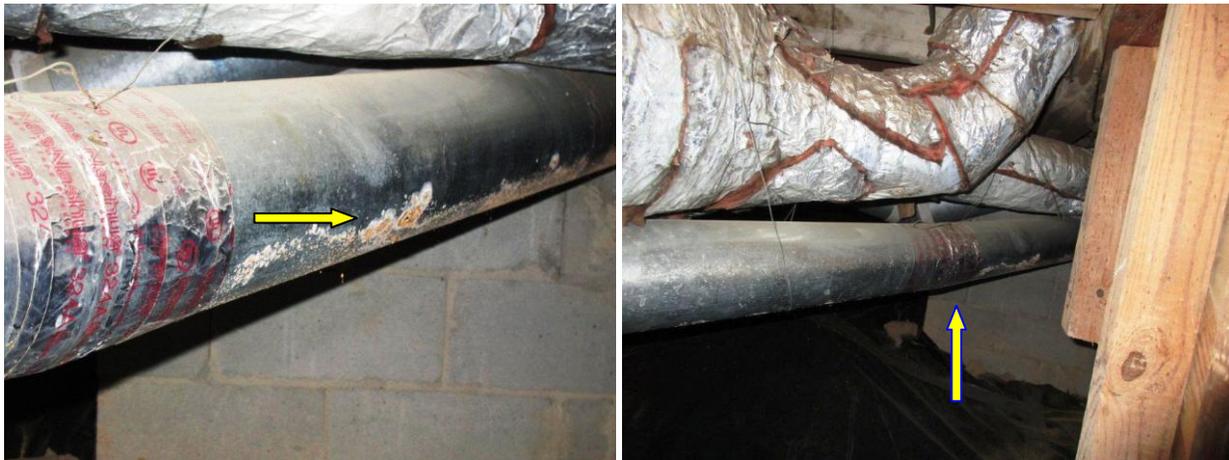
- **Repair, Safety Issue:** Evidence of substantial corrosion was noted at the furnace flue in the crawl space. The furnace flue has a negative slope which is not sufficient to allow the safe flow of exhaust gases. A qualified heating and cooling technician needs to be consulted to further evaluate this condition and make the necessary repairs. (Replace the damaged section and provide adequate support for the flue slope. A separate flue may be required in the chimney to prevent this corrosive condition).

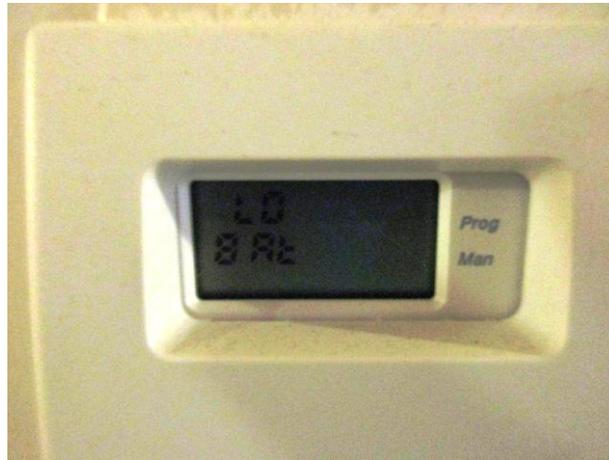
- **Repair:** The programmable thermostat was inoperative at the time of the inspection and requires new batteries.

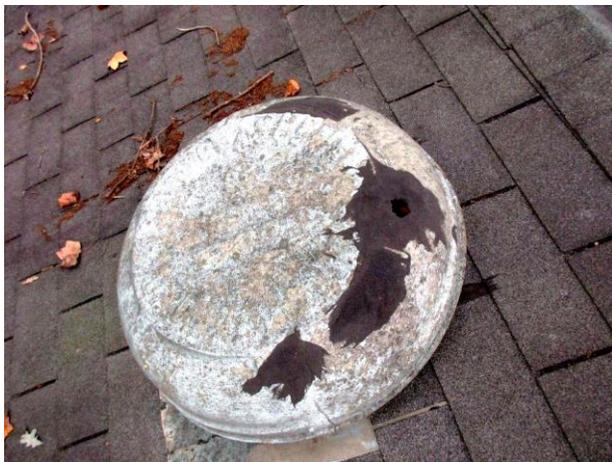
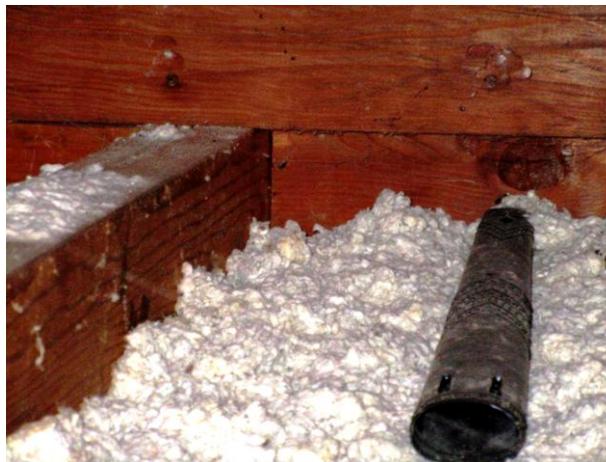
- **Repair:** There are very low levels of insulation. Insulation improvements may be cost effective, depending on the anticipated term of ownership.
- **Repair:** The attic ventilator fan was inoperative at the time of the inspection. This fan needs to be replaced when the roof is replaced. In lieu of replacing this fan, passive ventilation should be installed.

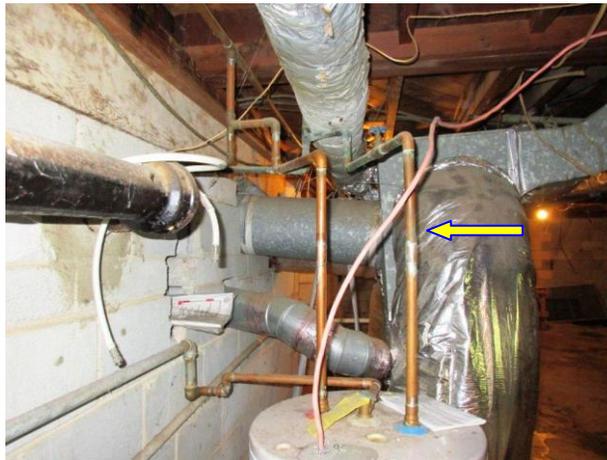
- **Repair, Safety Issue:** The water heater is missing the secondary expansion valve or tank. This has been a requirement since 1998. A qualified plumber needs to be consulted to further evaluate this condition and make the necessary repairs. Additional information about secondary expansion tanks can be found at: <http://www.watts.com/pages/learnAbout/thermalExpansion.asp?catId=64>

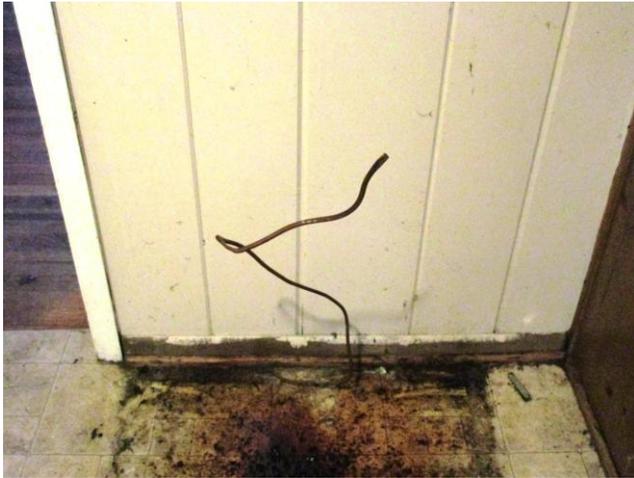
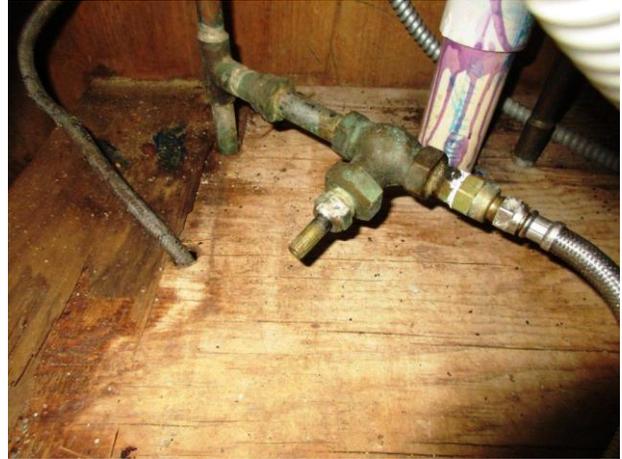
- **Repair:** There is no shut off valve on the cold water supply to the refrigerator. It is suggested that one be installed. A qualified plumber needs to be consulted to further evaluate this condition and make the needed repairs. (Should be in the same room as the appliance).
- **Repair:** The handle for the shut off valve at the dishwasher water supply is missing and needs to be replaced. A qualified plumber needs to be consulted to further evaluate this condition and make the needed repairs.

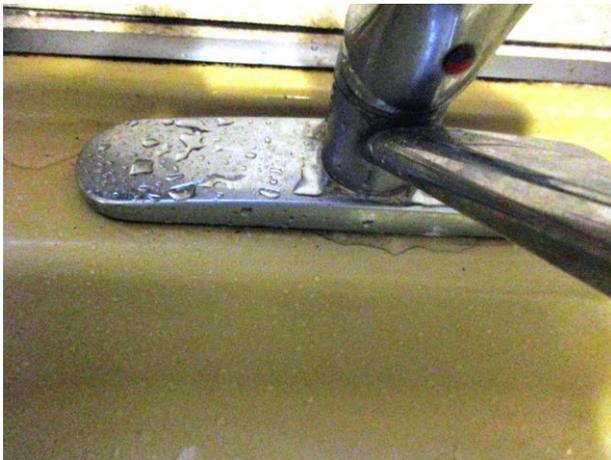
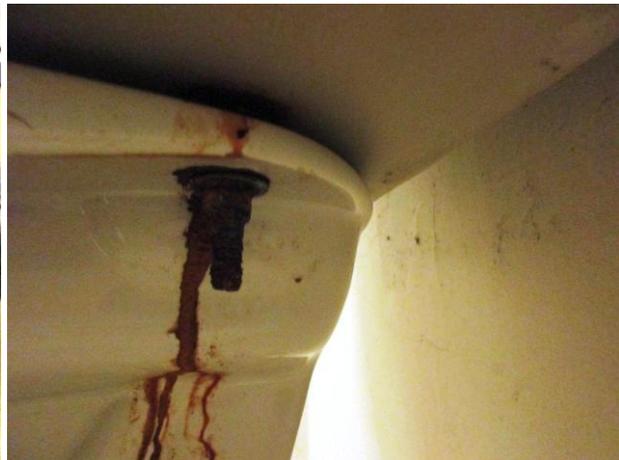
- **Repair:** The kitchen faucet is leaking. Replacement of this fixture is recommended. A qualified plumber needs to be consulted to further evaluate this condition and make the necessary repairs.
- **Repair:** The tank to the hallway bathroom toilet is loose and shows signs of leakage. A qualified plumber needs to be consulted to further evaluate this condition and make the necessary repairs.

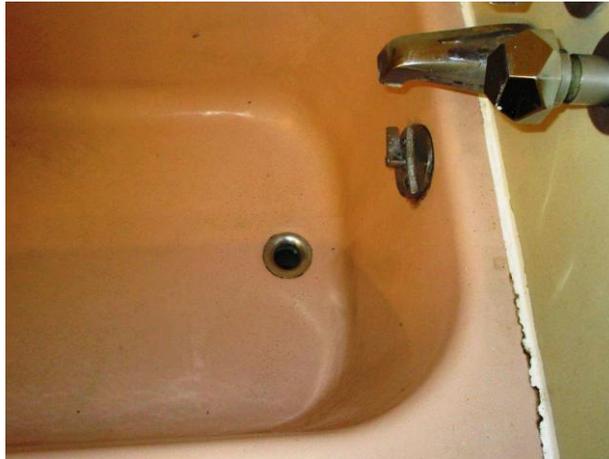
- **Repair:** The missing drain stops in the hallway bathroom sink and bathtub need to be replaced.

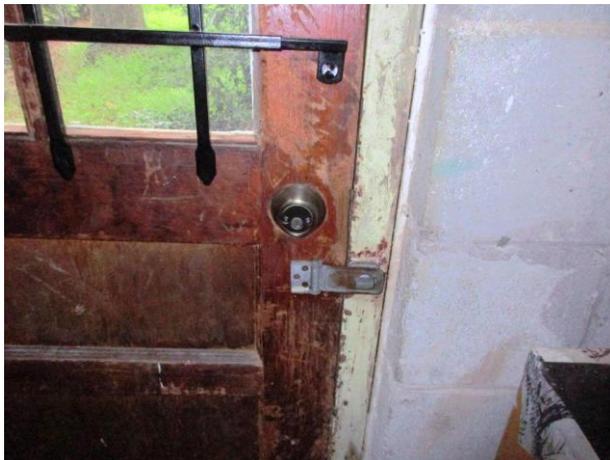
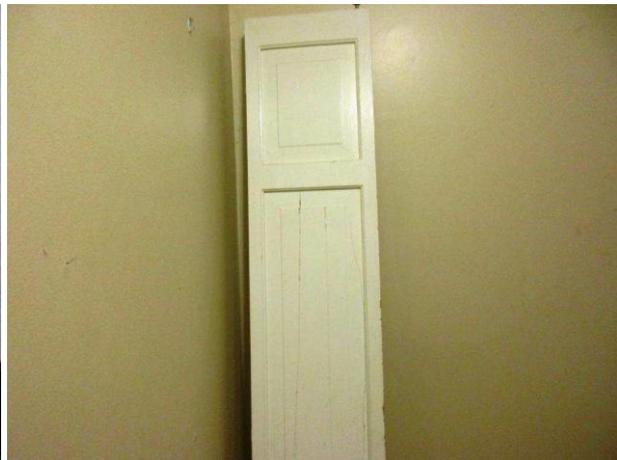
- **Repair:** It is recommended that handset be installed on the basement exit door.
- **Repair:** The kitchen pantry door and the left rear bedroom closet door need to be adjusted to latch properly.
- **Repair:** The bi-fold door for the family room needs to be replaced.

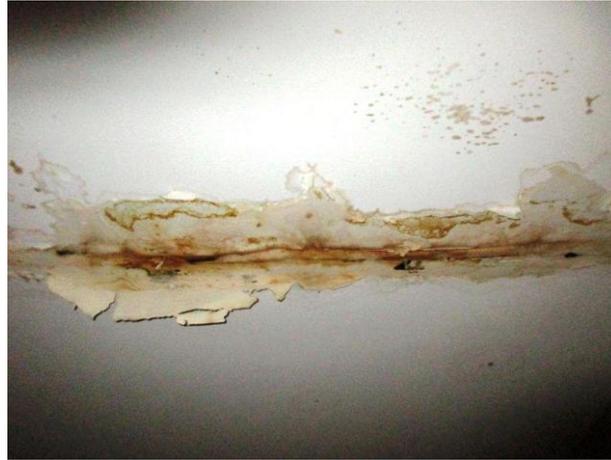
- **Monitor, Repair:** Possible active leaking was noted at the living room ceiling; some repairs to the roof were noted. Drywall repairs are needed.

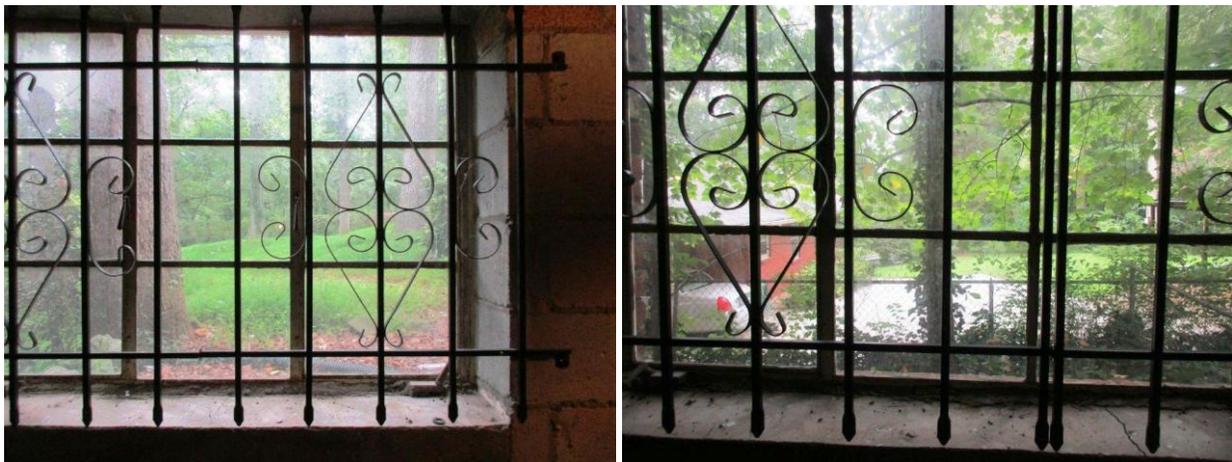
- **Repair, Safety Issue:** The steel bars on the basement windows need to be removed as a matter of safety.

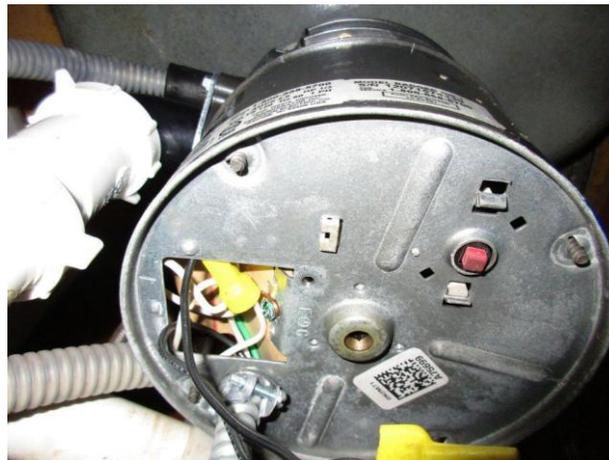
- **Repair:** The waste disposer is inoperative. A qualified appliance technician needs to be consulted to further evaluate this condition and make the necessary repairs.
- **Repair:** The missing electrical cover plate for the garbage disposal needs to be replaced to avoid a shock hazard.

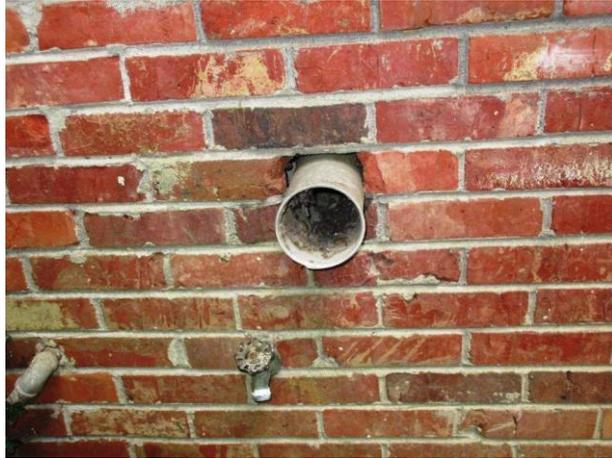
- **Repair:** A proper tail piece for the clothes dryer unit needs to be installed.

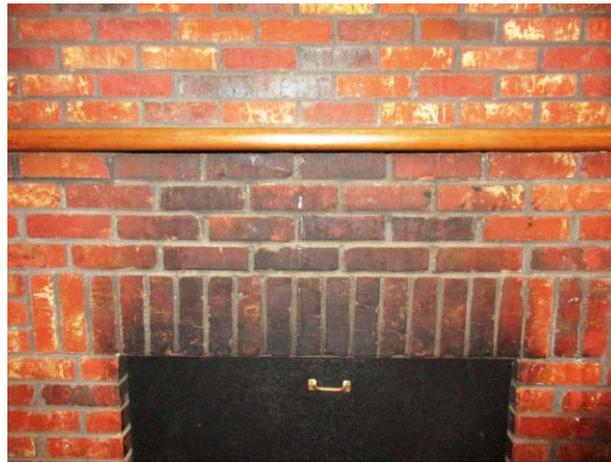
- **Repair:** The fireplace chimney needs to be cleaned and inspected prior to operation. A qualified chimney sweep contractor needs to be consulted to clean the chimney, inspect the chimney, and make any necessary repairs.
